TREE SURVEY REPORT

985 Montague Expressway
Milpitas, California

April 17, 2015

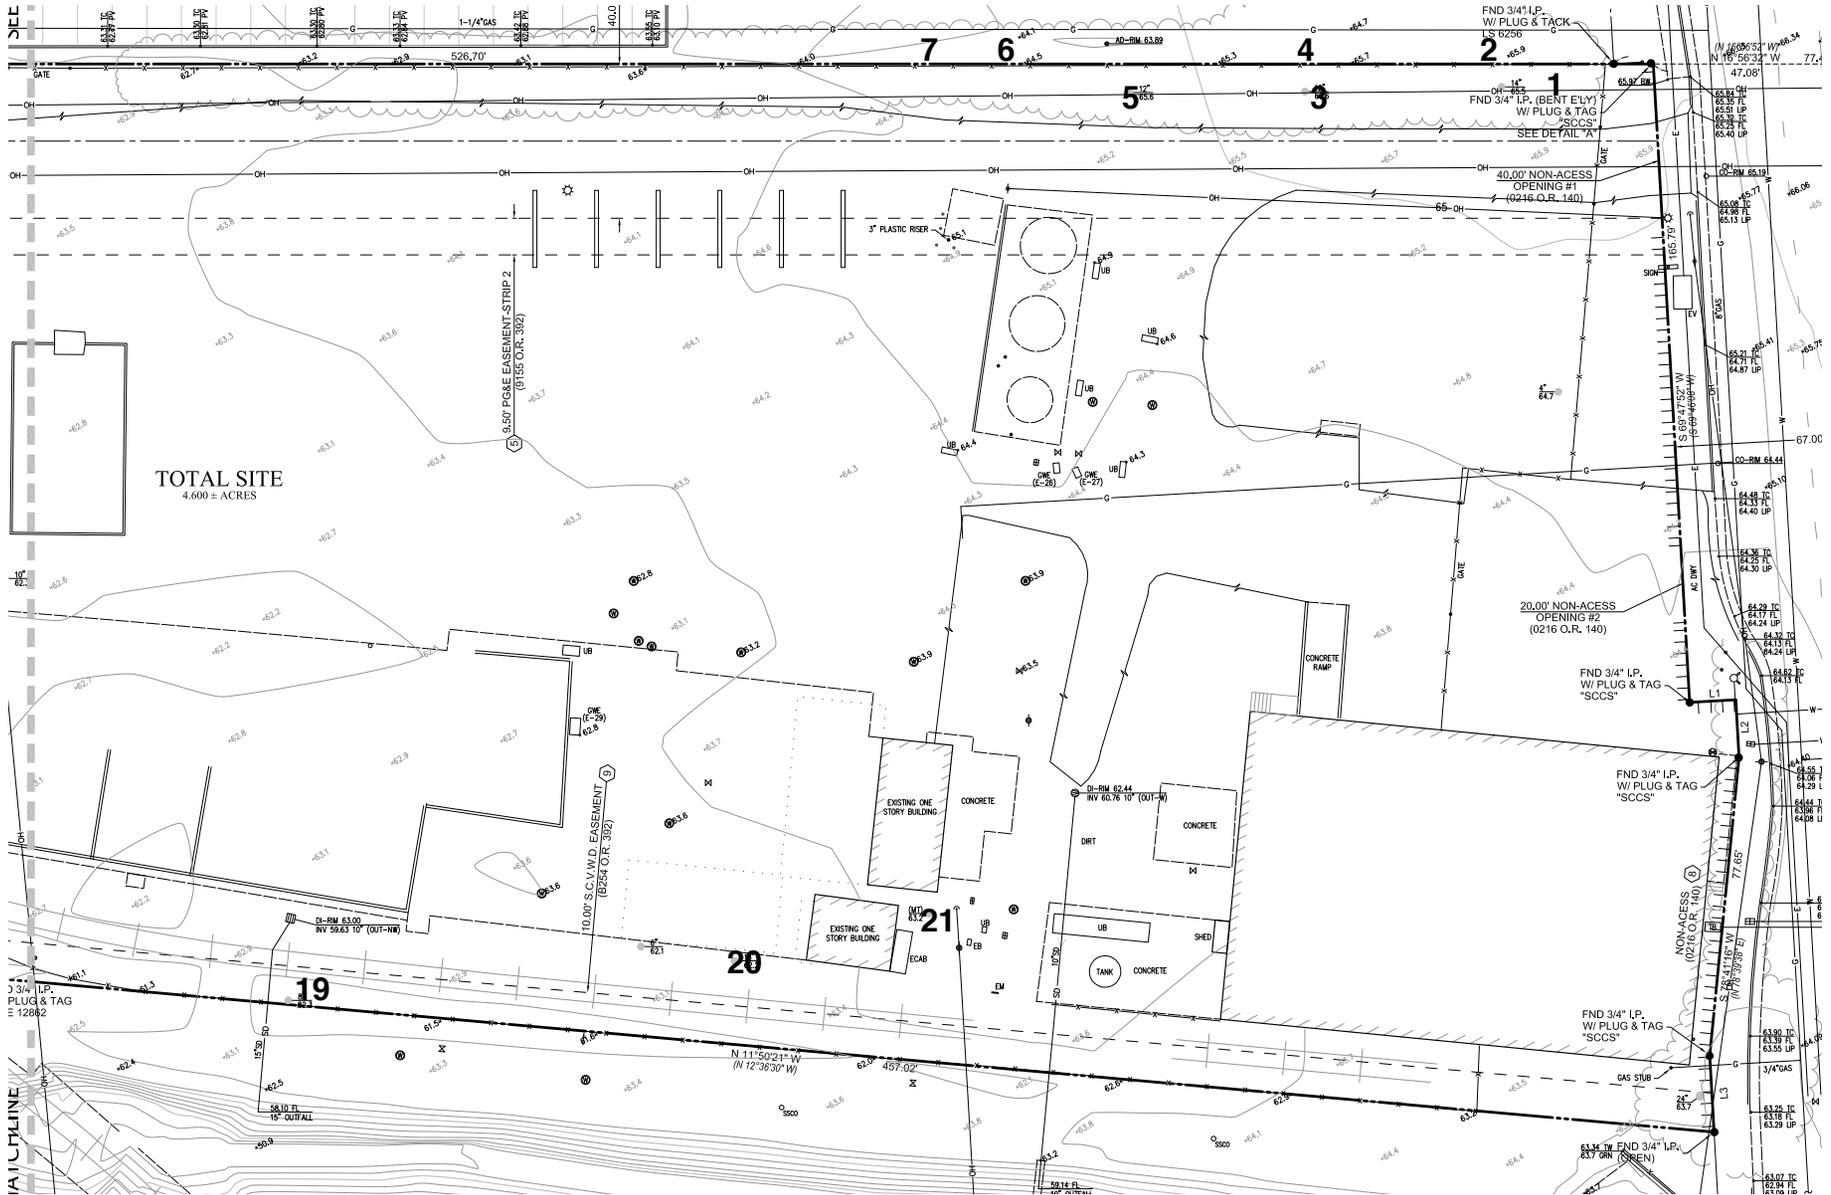
Tree Survey Map page 1

TREE No.	SPECIES	TRUNK DIAMETER (inches)	CONDITION 1=POOR 5=EXCELLENT	SUITABILITY FOR PRESERVATION	PROTECTED TREE ?	COMMENTS
1	Fruitless mulberry	17	3	Moderate	Yes	Previously topped.
2	Glossy privet	9	3	Moderate	No	Single trunk, high crown.
3	Fruitless mulberry	15	3	Moderate	Yes	Previously topped.
4	Glossy privet	8	3	Moderate	No	Trunk divides at 15'.
5	Fruitless mulberry	12	3	Moderate	Yes	Previously topped.
6	Eugenia	6,2,2	3	Moderate	No	Trunks attach at 3'.
7	Glossy privet	7	3	Moderate	No	Trunk divides at 5'.
8	Fruitless mulberry	27	3	Moderate	Yes	Large broken branch.
9	Olive	7,6,5	3	Moderate	No	Trunks attach at 1'.
10	Olive	6	3	Moderate	No	Trunk divides at 5'.
11	Ash	13	3	Moderate	Yes	Several broken branches.
12	Mexican fan palm	29	4	Good	Yes	Good form and health.
13	Eugenia	6,4,2	3	Moderate	No	Trunks attach at 1'.
14	Coast red elderberry	7,7,6,6,5,4	3	Moderate	No	Multi-stemmed at base.
15	Chinese pistache	7,76,6	3	Moderate	No	Trunks attach at 3'.

16	Brazilian pepper	7,7,6,6	3	Moderate	No	Trunks attach at 3'.
17	Mexican fan Palm	27	4	Good	Yes	Good form and health.
18	Coast red elderberry	10,8,8,6	4	Moderate	No	Trunks attach at 1'.
19	Mexican fan palm	11	4	Good	No	Good form and health.
20	Mexican fan palm	21	4	Good	Yes	Good form and health.
21	Coast red elderberry	6,4,3	3	Moderate	No	Trunks attach at base.
22	Valley oak	22	4	Moderate	Yes	Good form and health.

My recommendation is to remove the 13 trees growing in the oleander hedge that follows the east border of the site. In my opinion the trees do little to contribute to the visual screen provided by the hedge, and may cause it to decline due to competition for light and water. The eight trees on the western border are in locations where grading for buildings will occur, meaning they must be removed.

The valley oak (#22) grows off-site near the northwest corner of the property and is recommended for preservation. Preservation of this tree is predicated on following the **Tree Preservation Guidelines** that follow.
