Revised Arborist Report
300 Montague Expressway
Milpitas, CA

Prepared for:
Trumark Companies
4185 Blackhawk Plaza Circle, Suite 200
Danville, CA 94506

Prepared by:
HortScience, Inc.
2150 Rheem Dr., Suite A
Pleasanton, CA 94588

October, 2011

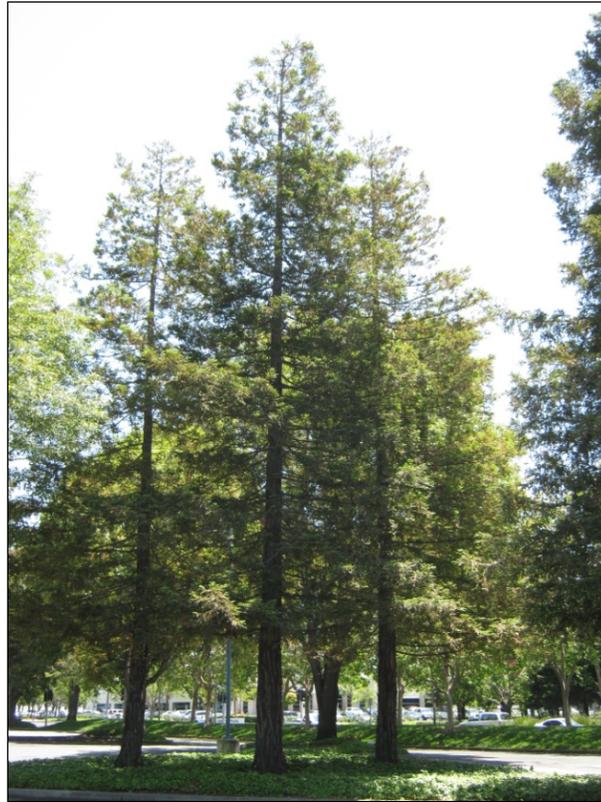
Photo 1: Looking south at coast redwoods #60-62. All three were in fair condition, with 'very thin crowns'. Tinning crowns in coast redwood is often associated with a lack of adequate summertime irrigation, but is reversible. The condition is more often associated with mature trees, which require more water, or those located in hot inland locations, well away from the cool, foggy coast where the species is native.
