## PRELIMINARY TREE REPORT

Trade Zone Boulevard  
Milpitas CA

**PREPARED FOR:**  
Warmington Residential CA  
2400 Camino Ramon, Suite 234  
San Ramon, CA 94583

March 27 2013

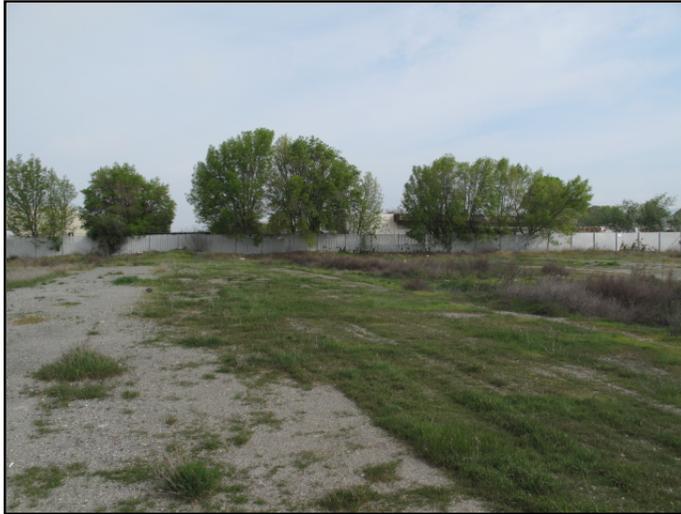
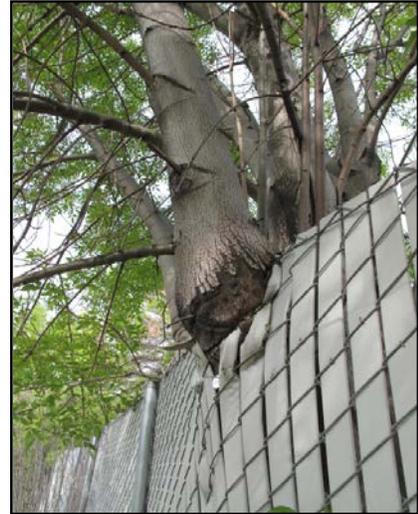
**Photo 1.** (above) Off-site trees to the north (#43-49) were planted close to a perimeter chain link fence (left). One of the main scaffolds on tree #44 was girdled by the wire fencing (right).

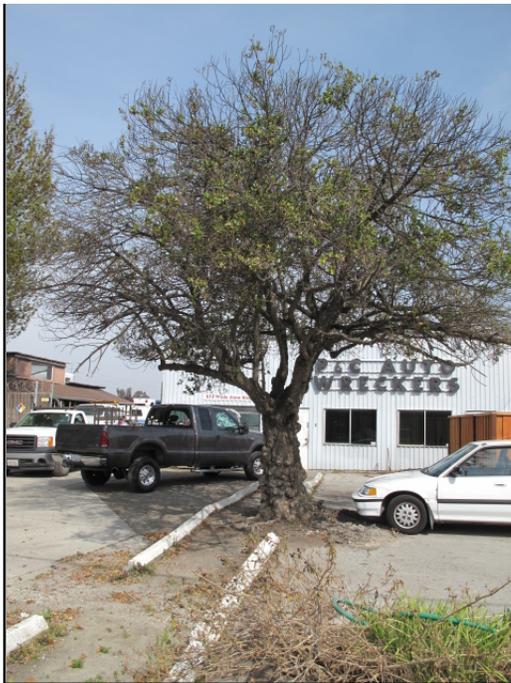
**Photo 2.** (left) This myoporum (#35) was in poor condition. It had surface rooting at the base, was surrounded by asphalt creating reflected heat. It is infested with myoporum thrips. Collectively, these conditions contributed to compromised tree vigor, as evidenced in the thinning canopy.

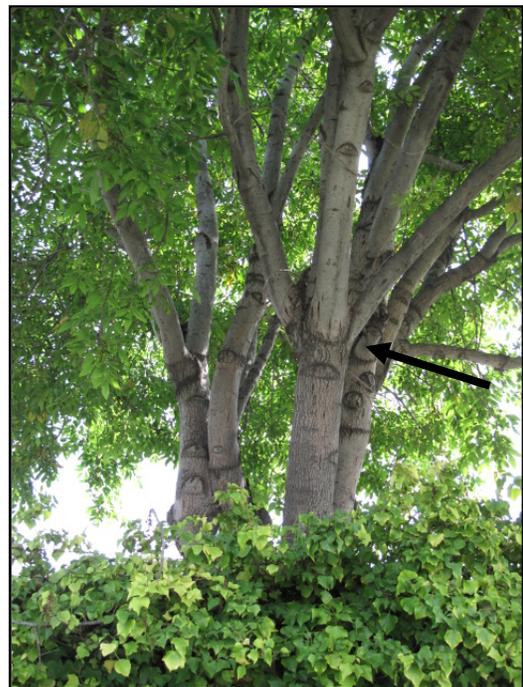
**Photo 3.** (right) Evergreen ash was the dominant species of all the on-site and off-site trees. Tree #62 on the right illustrates the poor structure typical of many of the evergreen ash trees assessed where multiple attachments originate at one point on the stem (arrow). Also visible is the thick ivy vine growing on the fence.

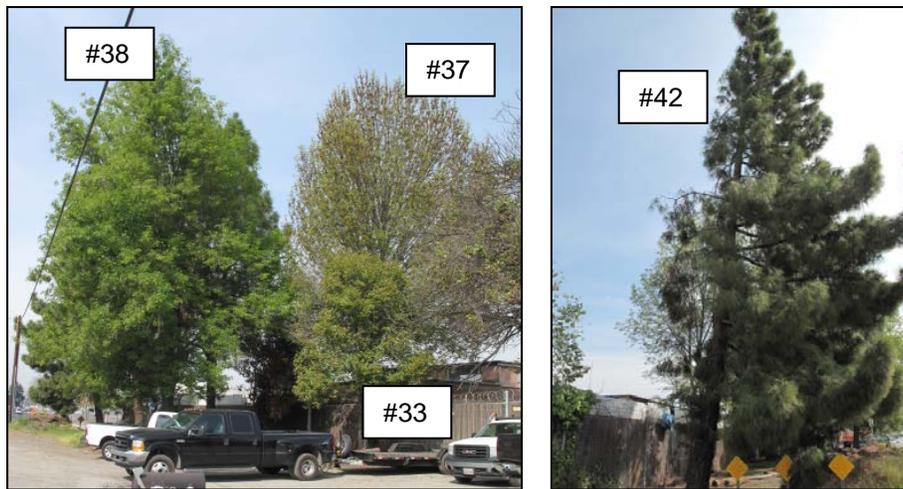
Photo 4: Evergreen ash #37 and 38, privet #36, and Canary Island pine #42 are among the eight on-site trees that would be removed as part of the project.

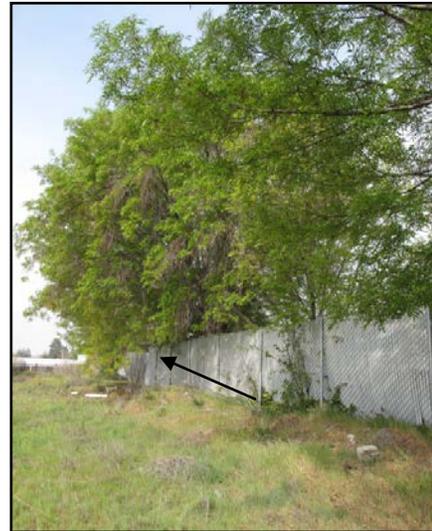
**Photo 5.** Pruning will be necessary to raise off-site tree canopies for equipment access (arrow, tree #60).

3. Off-site trees identified for preservation will require pruning to provide construction clearance. All pruning shall be completed by a Certified Arborist or Tree Worker and adhere to the latest edition of the ANSI Z133 and A300 standards as well as the Best Management Practices -- Tree Pruning published by the International Society of Arboriculture.
