Revised Arborist Report
1494-1600 California Circle
Milpitas, CA

Prepared for:
Trumark Companies
4185 Blackhawk Plaza Circle, Suite 200
Danville, CA 94506

Prepared by:
HortScience, Inc.
2150 Rheem Dr., Suite A
Pleasanton, CA 94588

December 2012

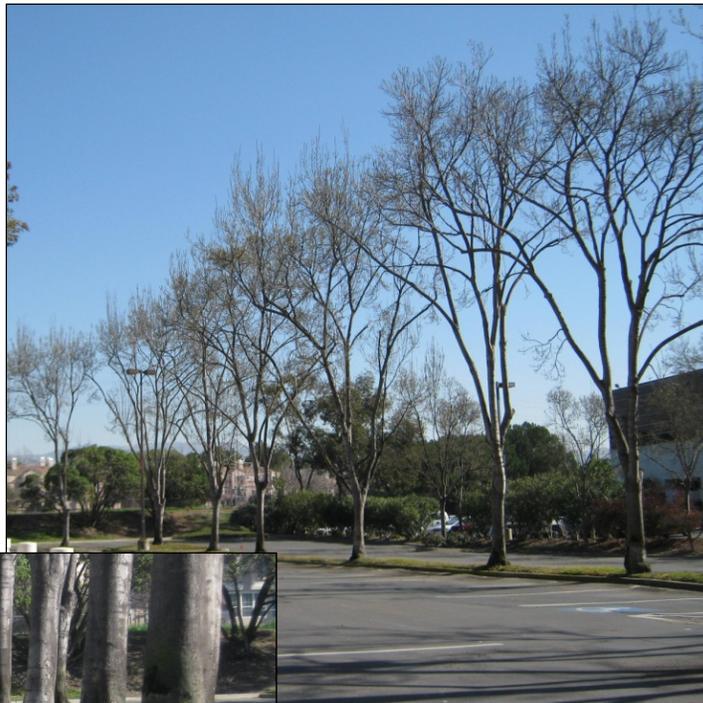
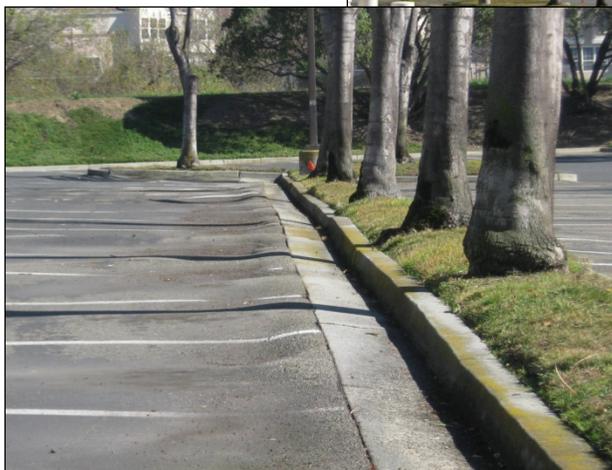
Raywood ash, with 20 trees, was the second most commonly encountered species. Sixteen (16) had been planted in the southern parking lot and four (4) were located in the landscape bed between the two buildings. In general, the trees had performed well, with half in good condition and half in fair condition. Most notably, the trees had been planted in small parking lot islands, where surface roots had lifted and displaced the surrounding infrastructure. Fourteen of the 16 trees in the southern parking lot were noted as displacing the curbs and asphalt from 2" to 6" (Photo 1).

Photo 1 (R): Looking east at raywood ash trees #12-18. The trees were all in fair condition, having been planted in small parking lot islands. Inset below shows the size of the parking lot island relative to the trees trunks and the level of infrastructure damage caused by the trees.
