Type of Services	Phase I Environmental Site Assessment and Preliminary Phase II Soil, Ground Water, and Soil Vapor Quality Evaluation
Location	569, 573, 595 and 615, and 625 Trade Zone Boulevard Milpitas, California
Client	Warmington Residential California
Client Address	2400 Camino Ramon, Suite 234 San Ramon, California 94583
Project Number	573-1-1
Date	November 6, 2012

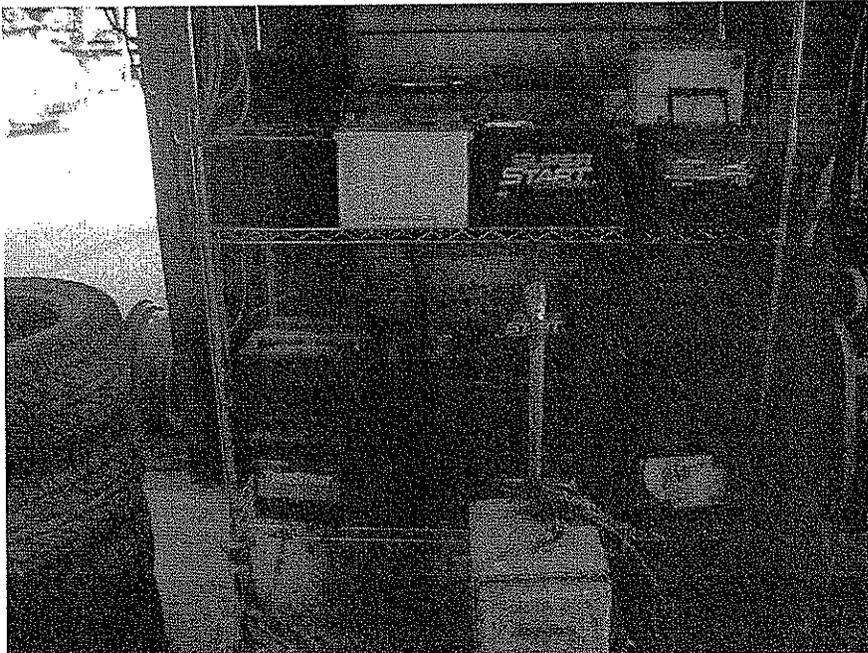
Photograph 8. Battery storage rack within dismantling structure.

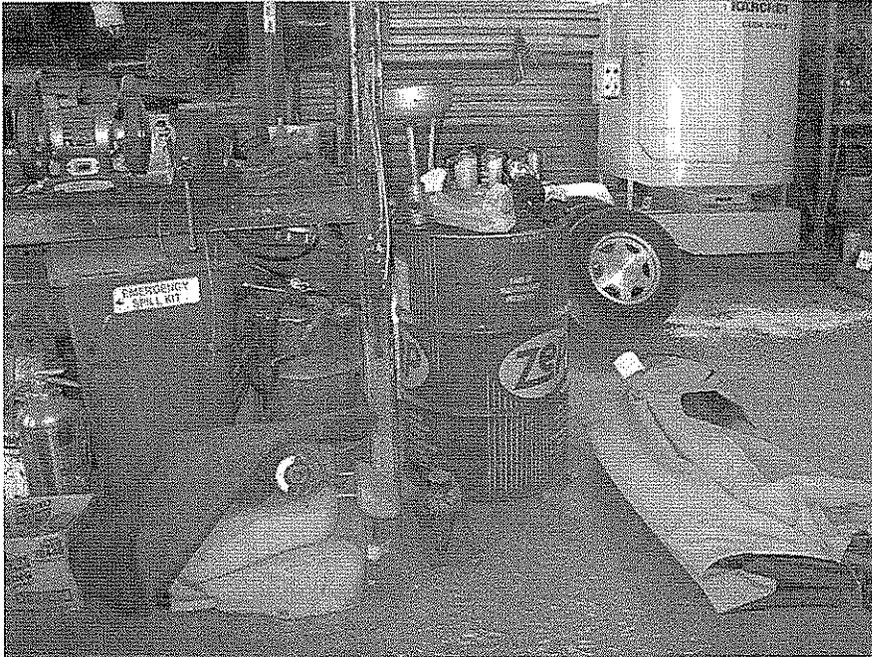
Photograph 9. Emergency spill kit, parts, tools, parts cleaner with minor spill covered with absorbent within eastern side of dismantling structure.

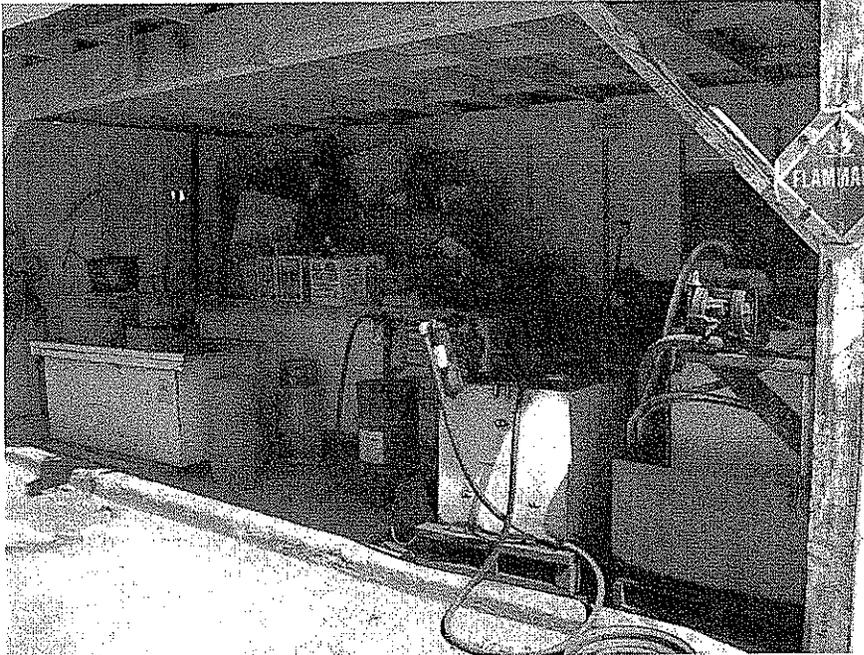
Photograph 11. View of hazardous materials and flammables storage area, within secondary containment berm.

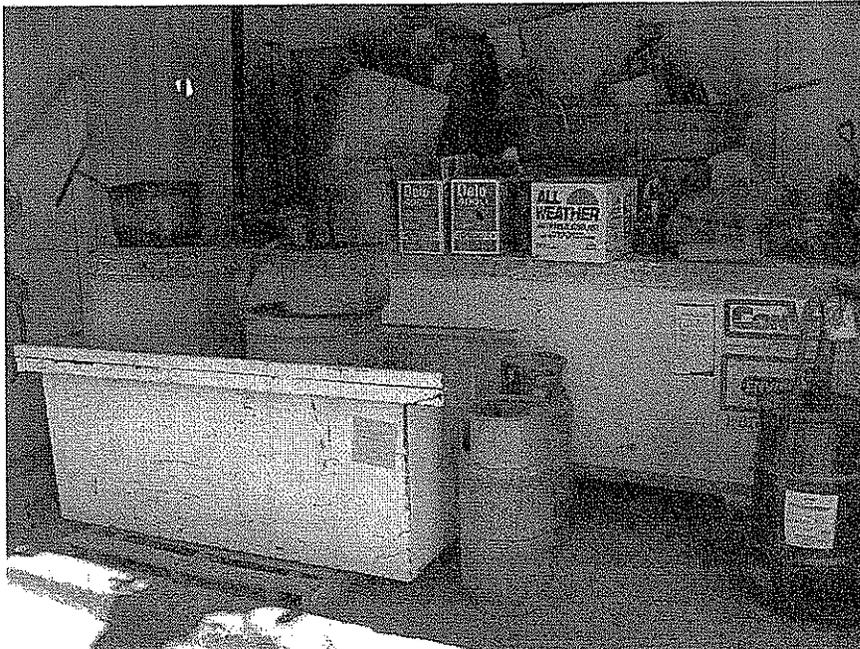
Photograph 12. Gasoline AST (within concrete containment vault), drums within steel secondary containment, stored within hazmat storage area.

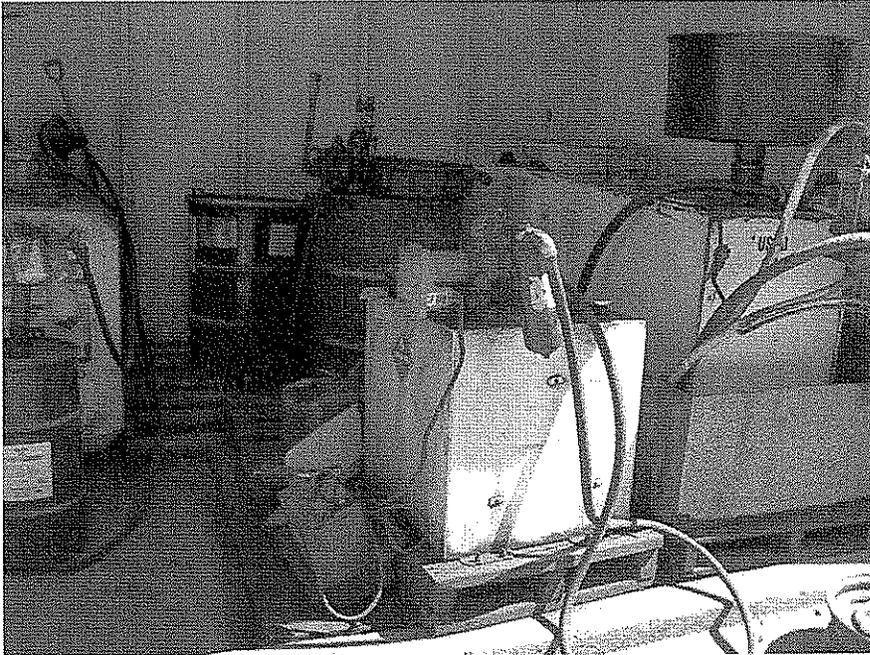
Photograph 13. Various hazardous materials stored within hazmat storage area including waste oil storage tank, diesel tank, within steel secondary containments, drums on pallets, gas can, battery.

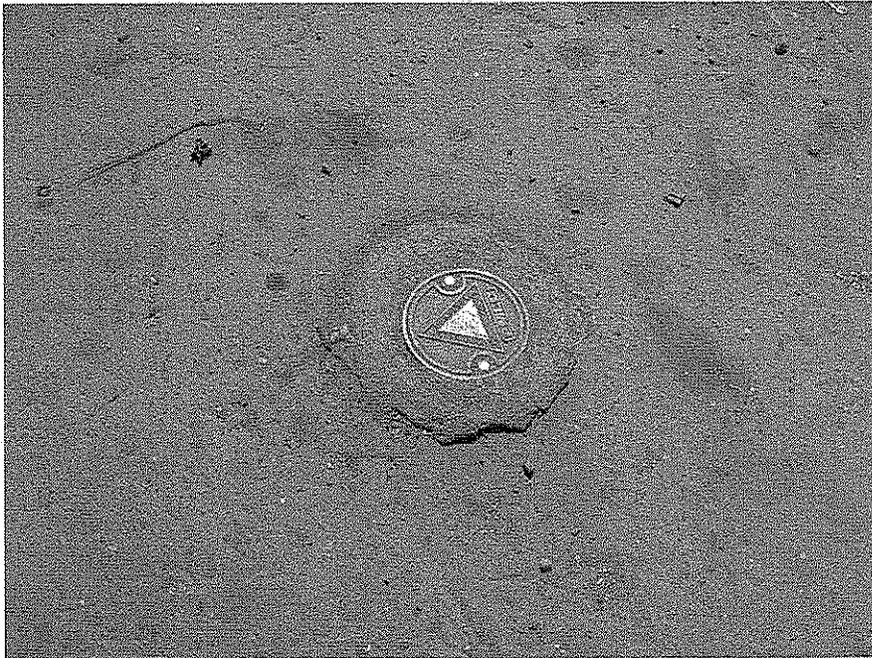
Photograph 14. View of monitoring well cover used to protect existing soil vapor probe location along north side of dismantling structure.

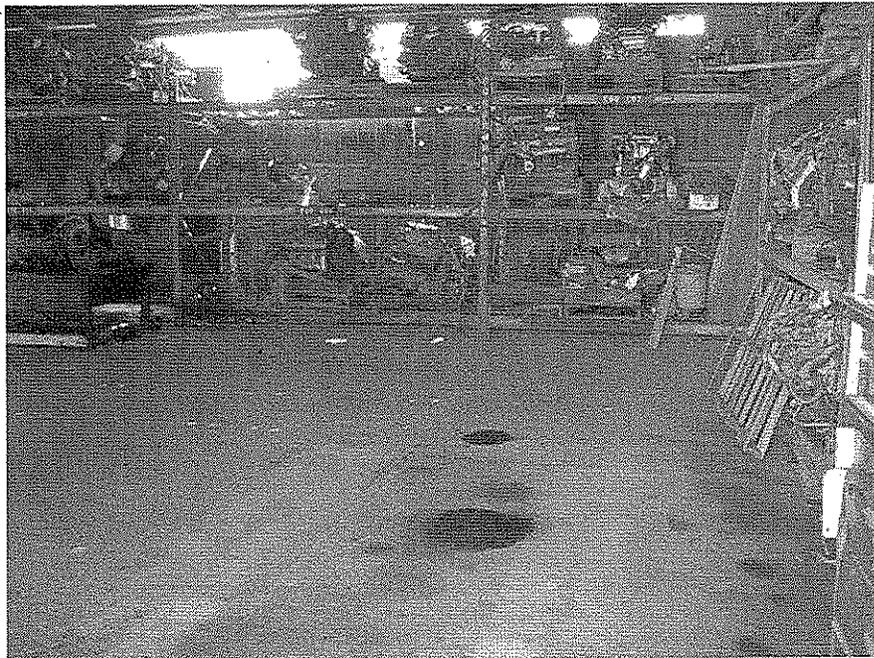
Several minor spills to concrete surfaces were observed within the two dismantling/engine draining buildings. Spills within the dismantling building were observed to be treated with absorbent material. Several areas of dark colored soil were observed in the vicinity of the dismantling/engine draining buildings.

Photograph 18. Engine storage within fluid and engine drainage structure, note minor spills on concrete floor.

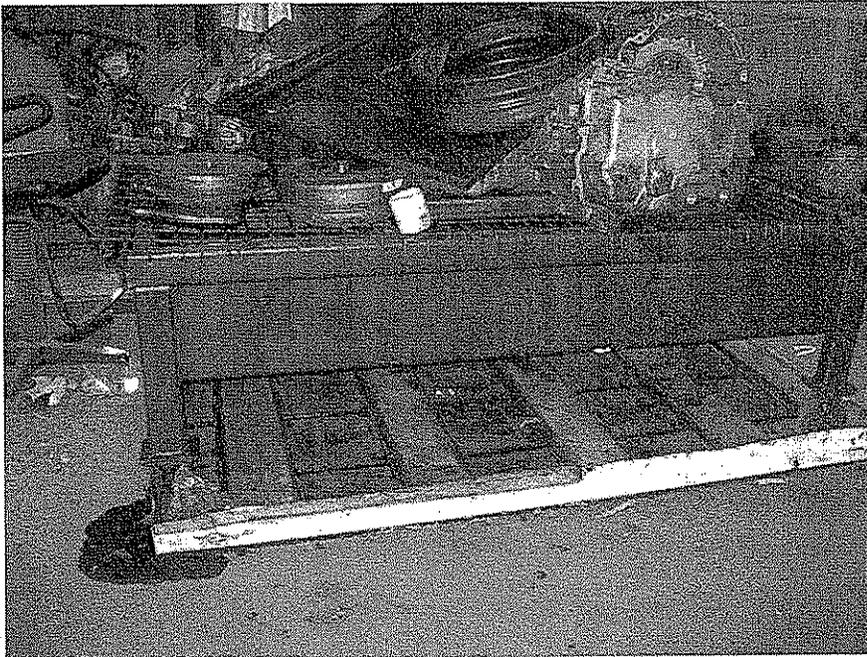
Photograph 19. Metal drain rack with secondary containment beneath, located within fluid drainage structure. Note minor spill on concrete floor.

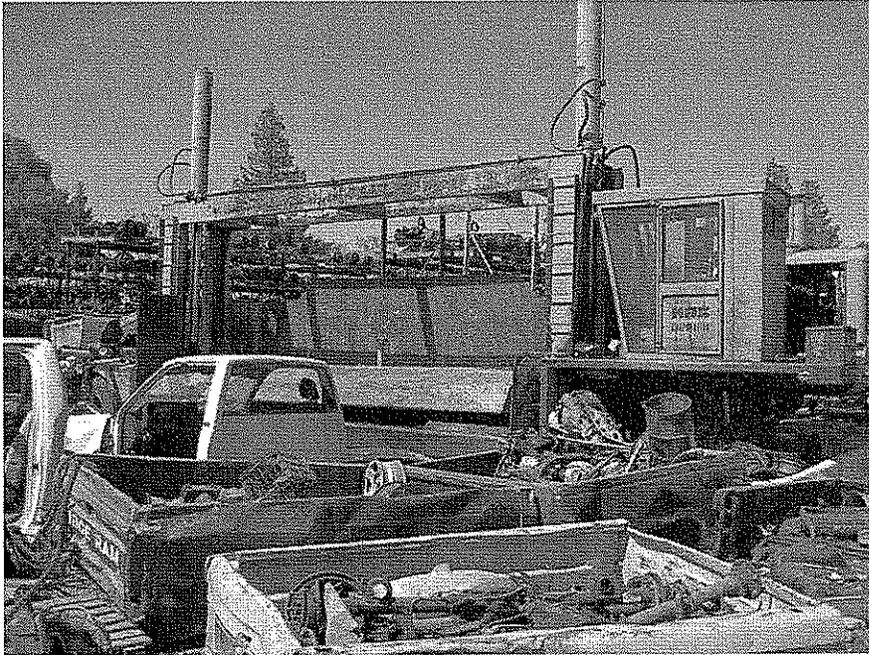
Photograph 21. Car crusher located in central portion of parcel.

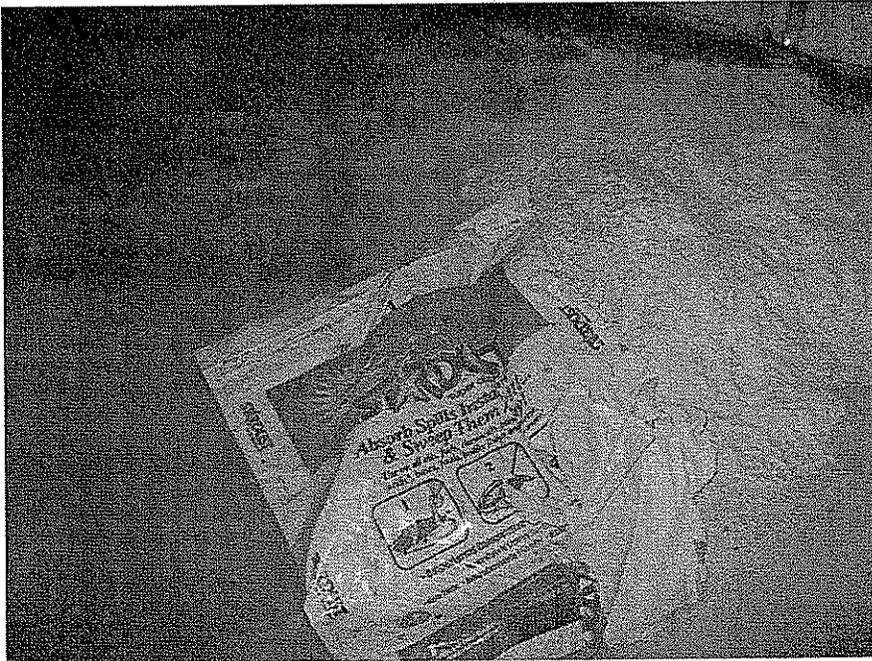
Photograph 28. Pile of white powdery substance next to empty bag labeled spill absorbent (photo taken October 2011).

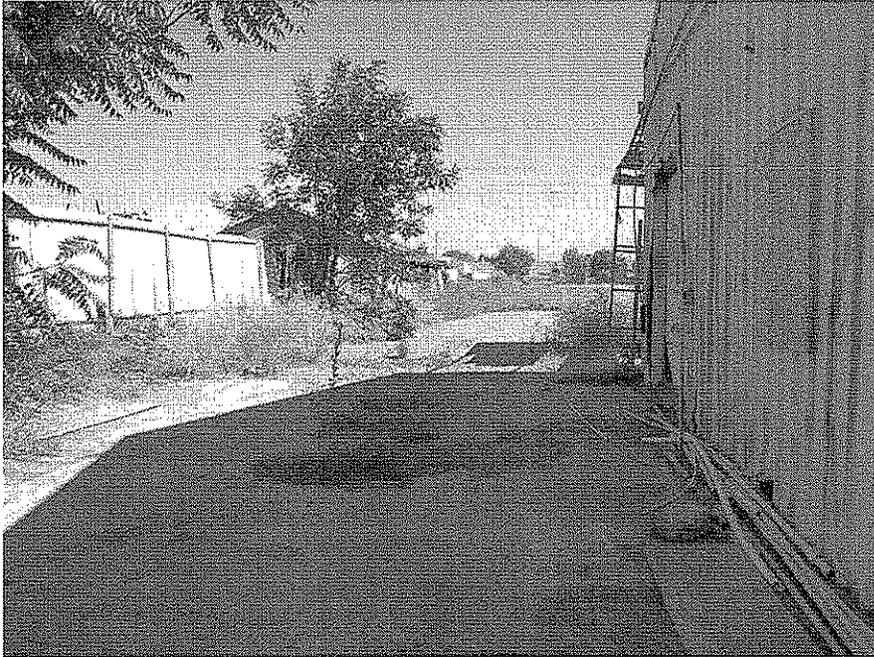
Photograph 29. Reported additional former steam cleaning area and location of septic tank along western side of office/shop structure.

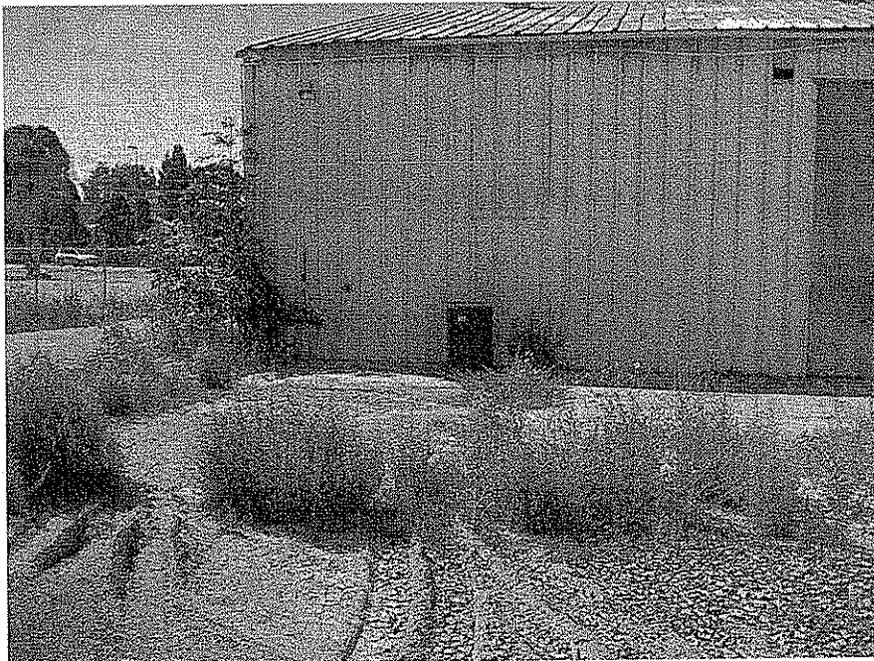
Photograph 31. Drum stored along northern side of office/shop structure.

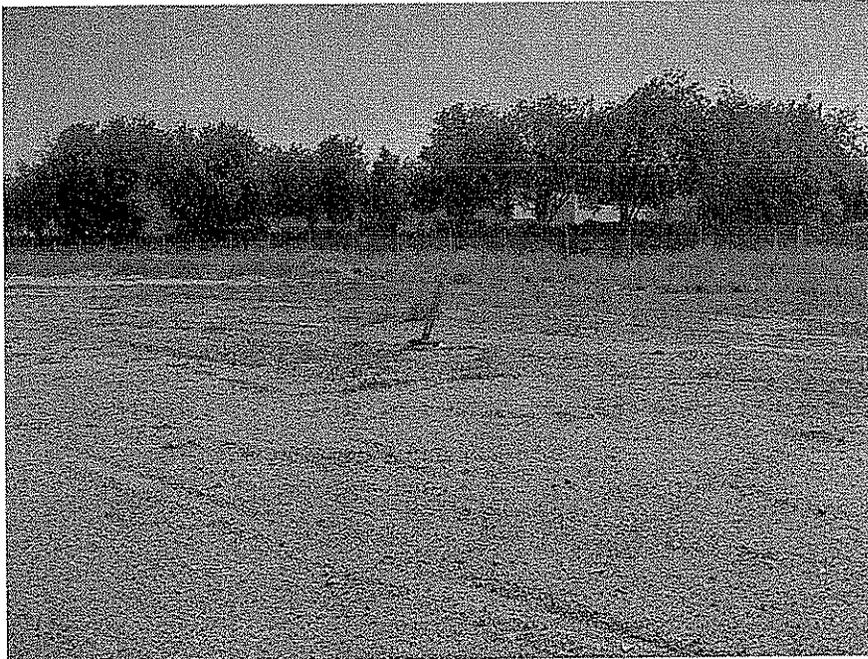
Photograph 35. View of former steam cleaning excavation area along eastern side of parcel.

Cornerstone previously visited the Site in October 2011 during a preliminary excavation of a former steam cleaning area along the eastern side of the property by ECA. Four exploratory trenches were excavated to approximately 5 feet on each side of the concrete pad. No odors or stained soil were observed from the exploratory trenches, however, odorous and grayish soil was observed directly beneath the drain grate in the center of the pad. Eric Lautenbach, representative of ECA, stated that they planned to return on October 12, 2011 to excavate the impacted soil from beneath the concrete pad.

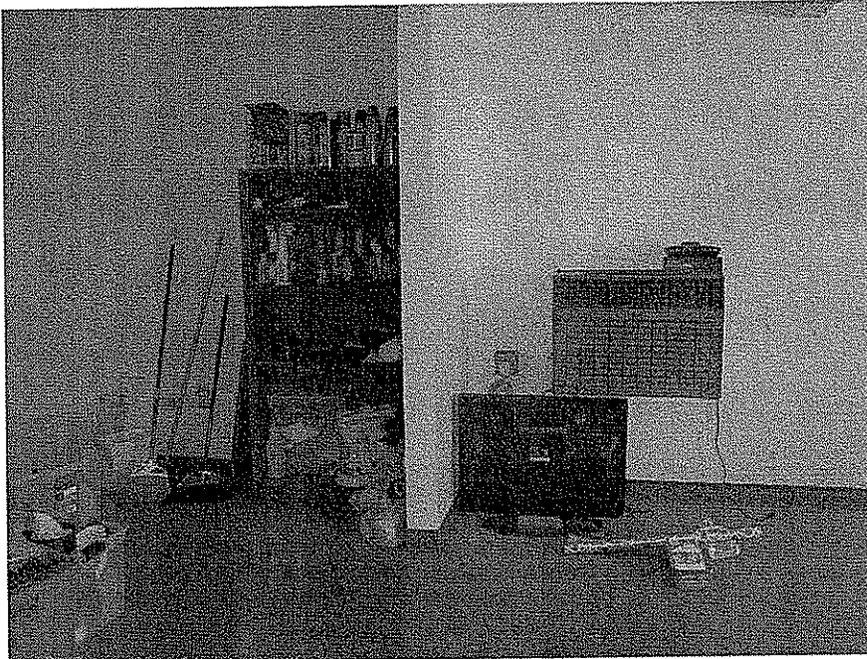
Photograph 42. Compressed cylinder, stored beneath desk.

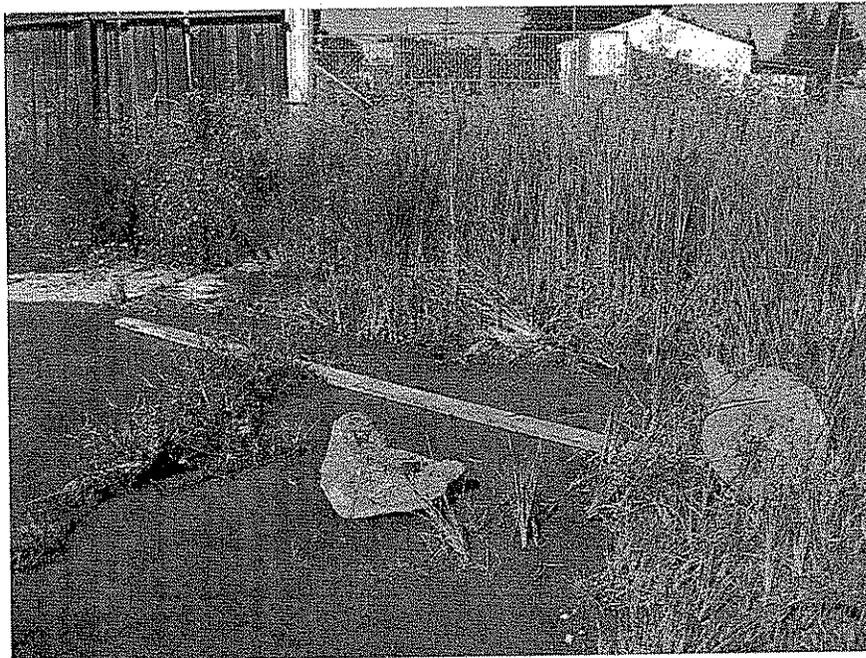
Photograph 48. Approximate area of well, reportedly "uncapped" with water flowing from the top.

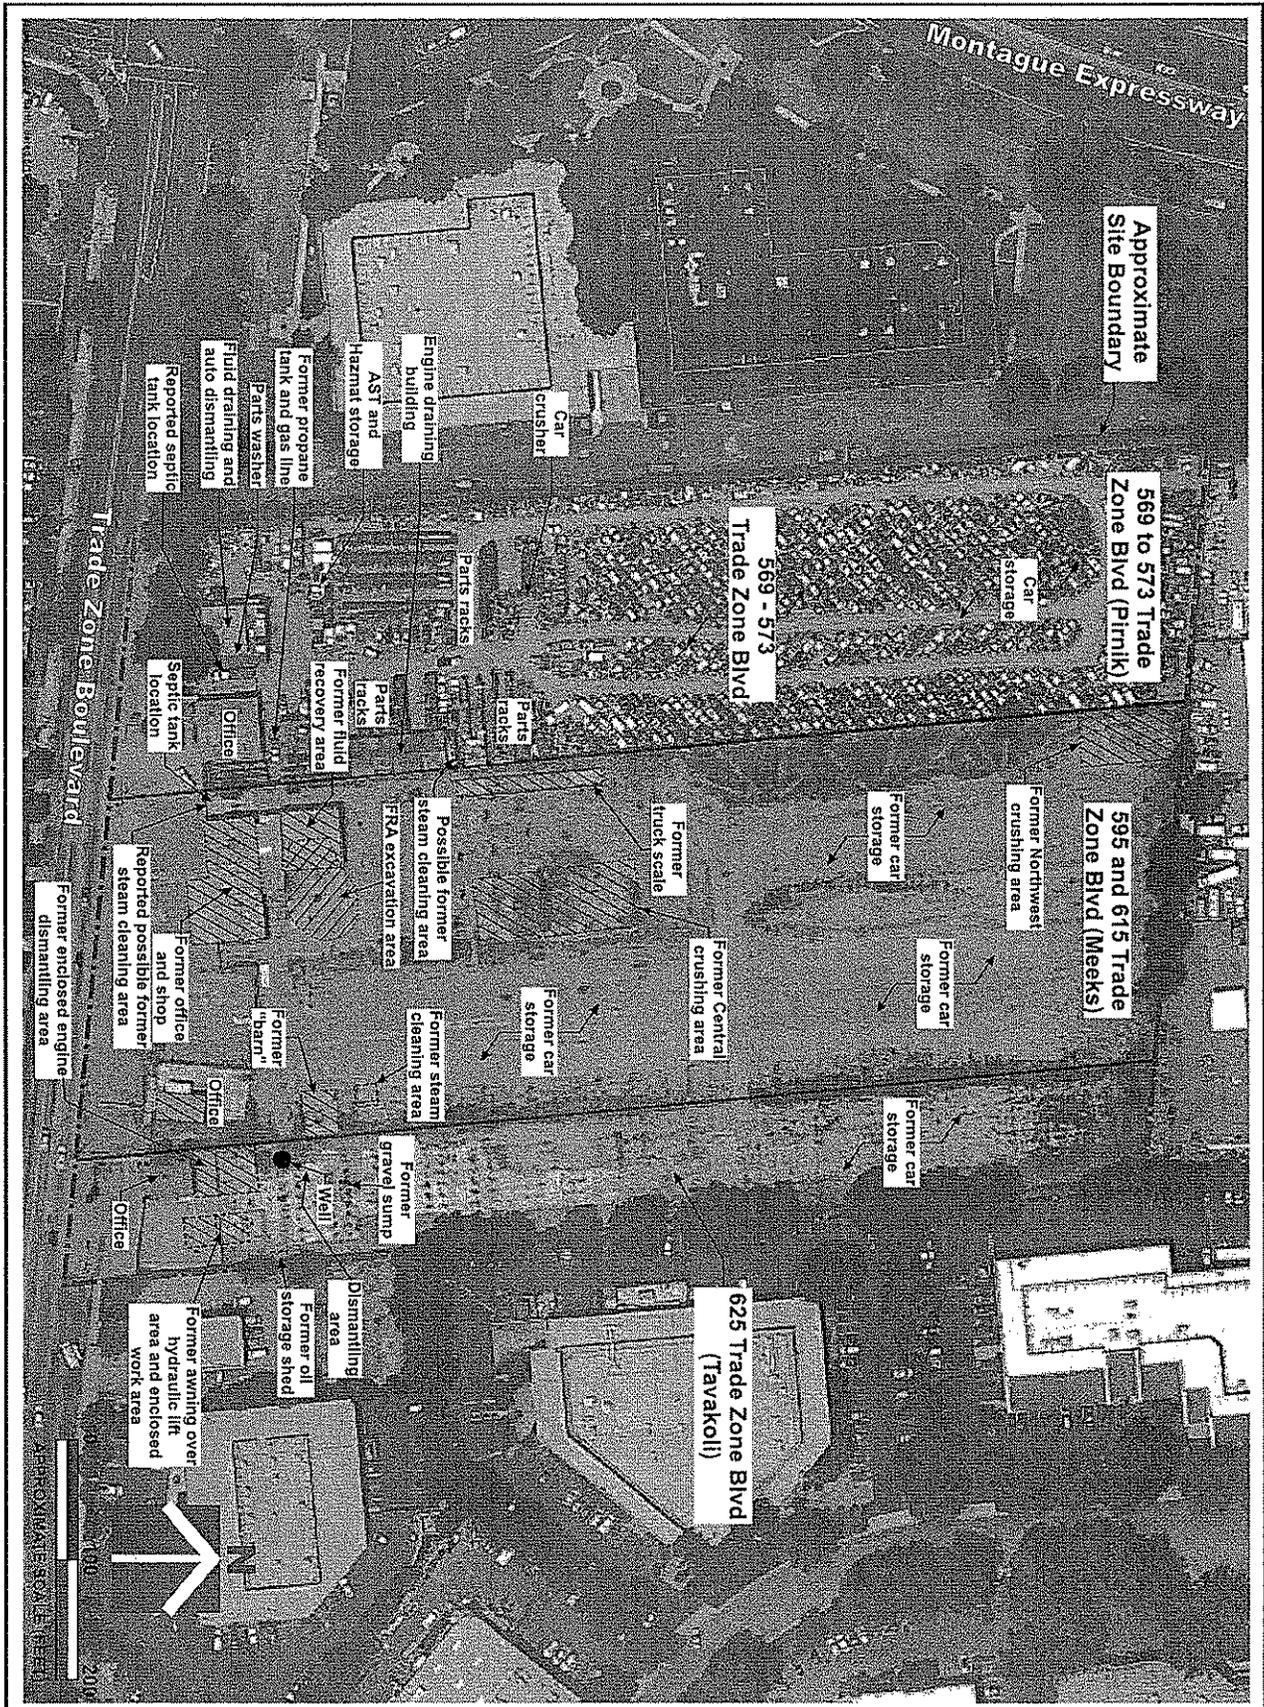
CORNERSTONE EARTH GROUP	Site Plan		Project Number 573-1-1		
	569 to 573, 595, 615 and 625 Trade Zone Boulevard Milpitas, CA		Figure Number Figure 2		
			Date August 2012	Drawn By RRN

recommended that surface soil excavation be conducted in the central crushing area and fluid recovery area (Figure 2).

According to ECA's recommendations (ECA, April 2011), soil cleanup activities were recommended to be performed at the Central Crushing Area and Fluid Recovery Area. The approximate boundaries of excavated soil in the Fluid Recovery Area are shown on Figure 2. Additionally, ECA recommended in their April 2011 report that surface soil staining locations and areas of auto debris should be scraped and disposed and following this cleanup, no further soil cleanup and further ground water related actions appeared warranted.
