# CONCEPTUAL HISTORIC RESOURCES MASTERPLAN for the City of Milpitas

prepared by the  
CITY OF MILPITAS  
and  
ARCHITECTURAL RESOURCES GROUP

# Standards for Rehabilitation & Guidelines for Rehabilitating Historic Buildings

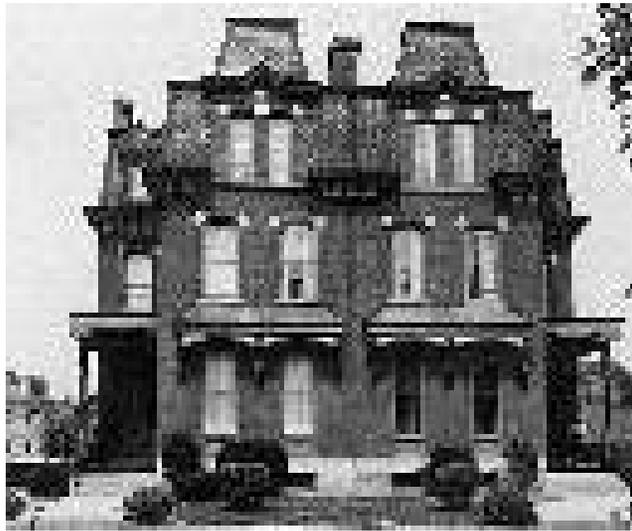
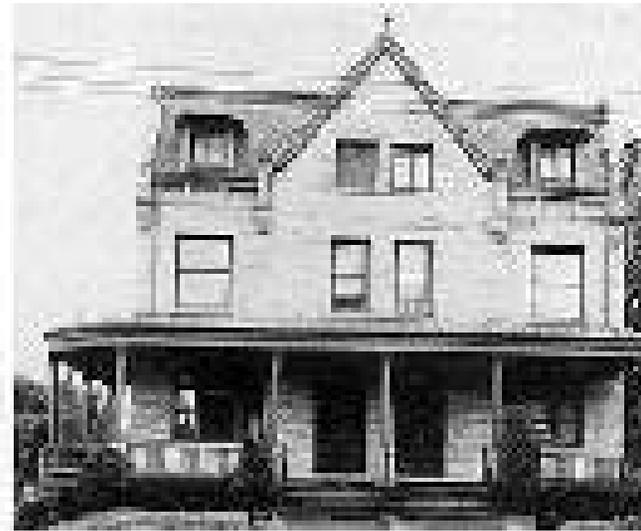
*Originally built as single-family, semi-detached duplexes, these houses were rehabilitated for a new use as rental apartments. While some alteration to non-significant interior features and spaces was necessary in each one, the exteriors were essentially preserved. Photos: Mistick, Inc.*

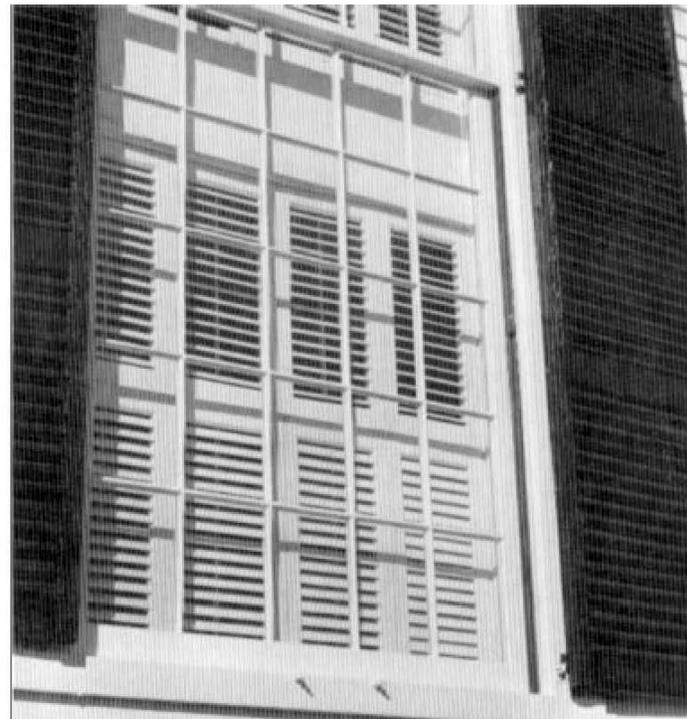
*According to the Standards for Rehabilitation, existing historic materials should be protected, maintained and repaired. In an exemplary project, the windows and shutters of this historic residence were carefully preserved.*

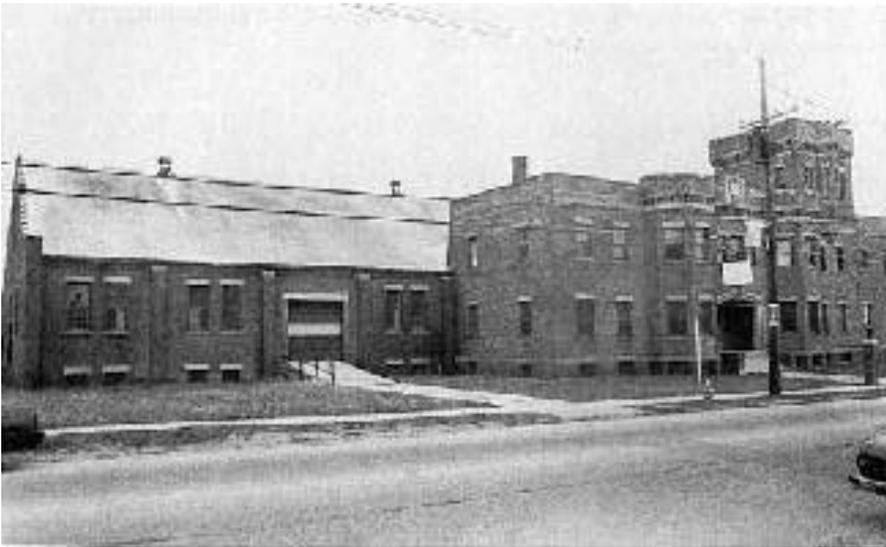
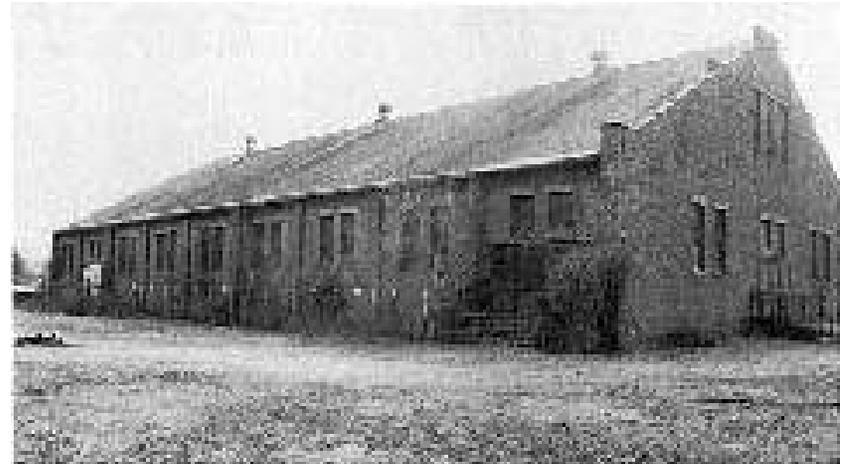
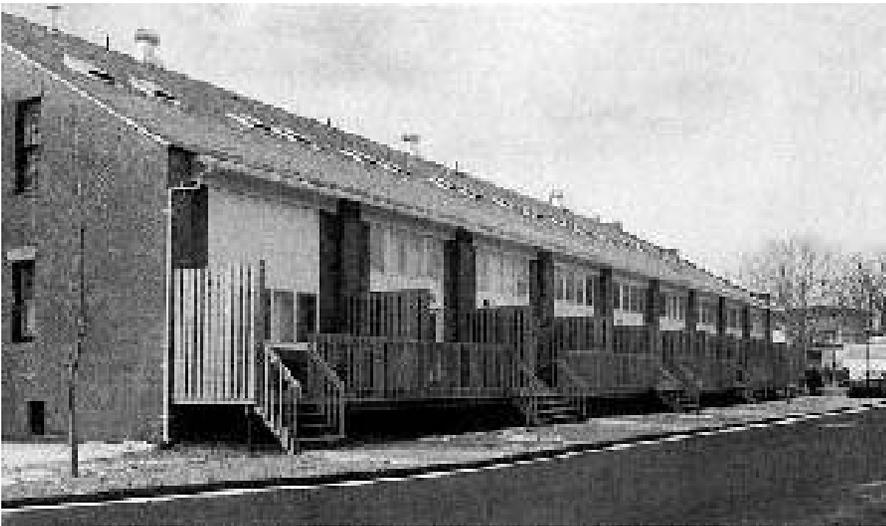
*(a) An armory complex was rehabilitated for rental housing. (b) This view of the rear elevation shows the paired, nine-over-nine wood sash windows and high sills that characterized the building. (c) After inappropriate rehabilitation work, the same rear elevation is shown with new skylights added to the roof, prefabricated panels filling the former brick areas, and new wood decks and privacy fences. Because the work changed the historic character, the project did not meet the Standards.*

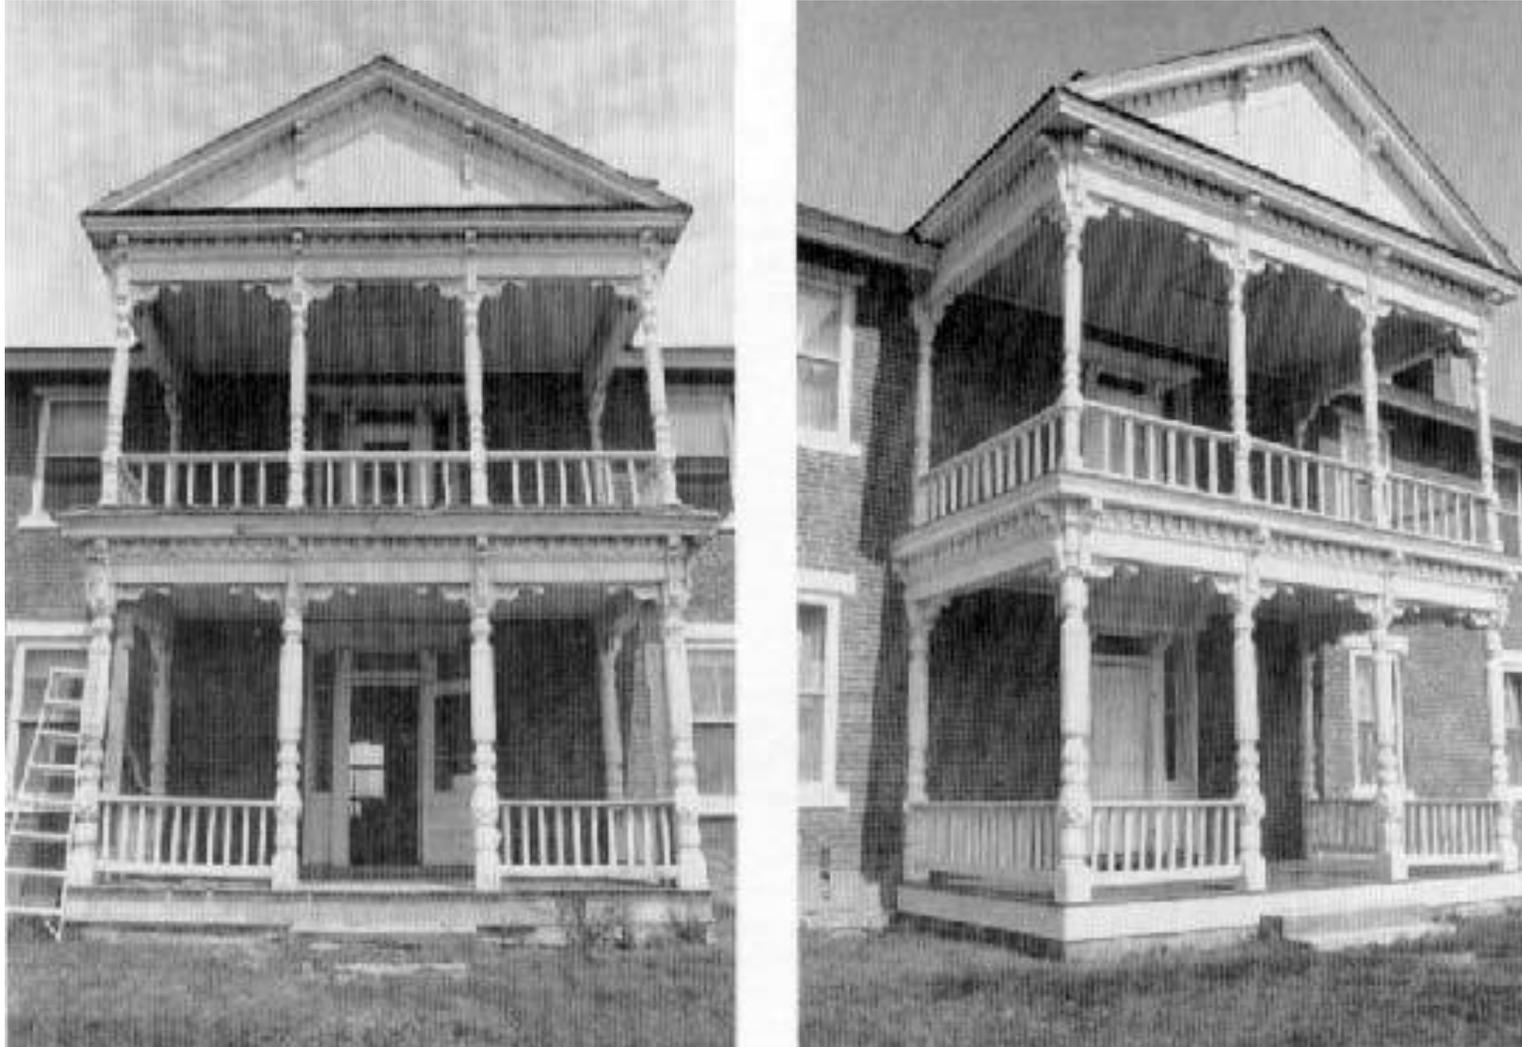
*In Rehabilitation, deteriorated features should be repaired, whenever possible, and replaced when the severity of the damage makes it necessary. Here, a two-story porch is seen prior to treatment (left). The floor boards are rotted out and the columns are in a state of collapse, supported only by crude, temporary shafts. Other components are in varying stages of decay. Appropriate work on the historic porch (right) included repairs to the porch rails; and total replacement of the extensively deteriorated columns and floor boards. Some dismantling of the porch was necessary.*

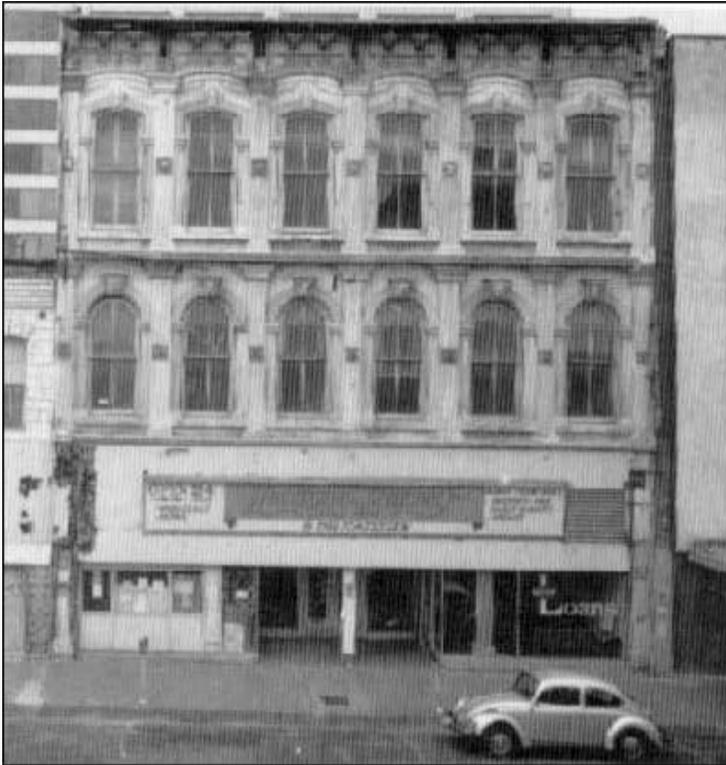
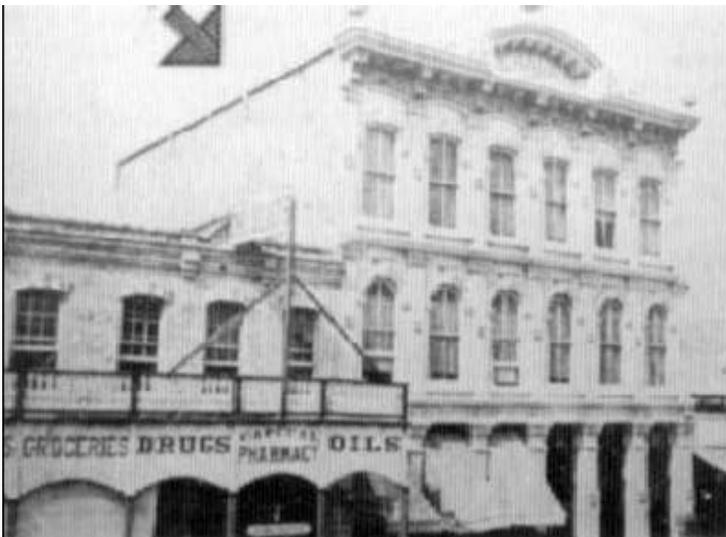
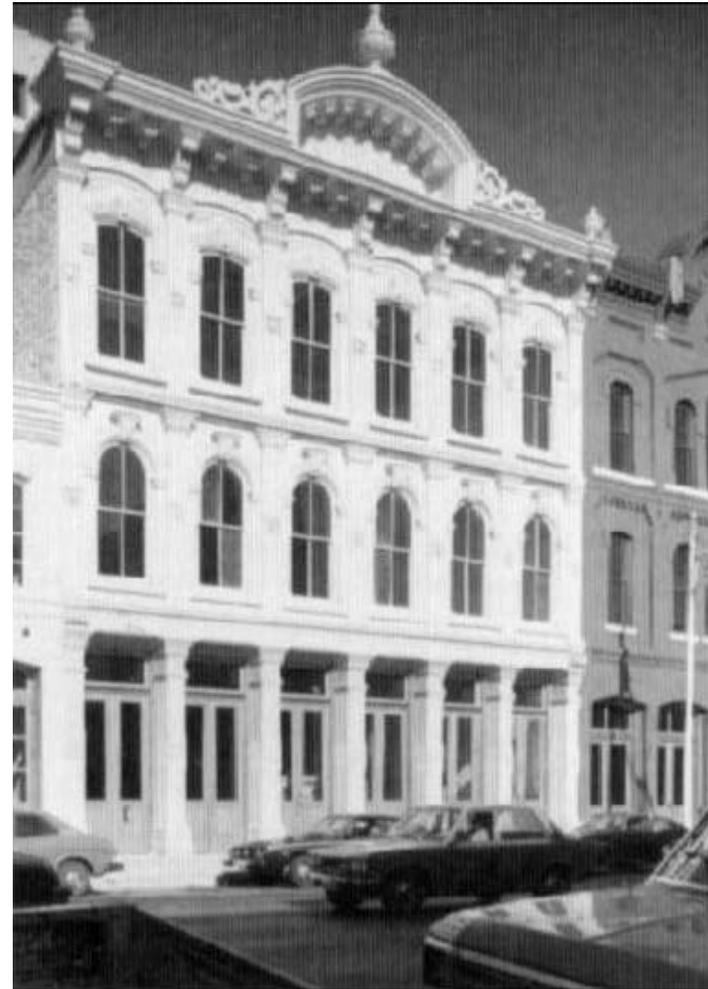
*In the treatment, Rehabilitation, one option for replacing missing historic features is to use pictorial documentation and/or physical evidence to re-create the historic feature. (a) In this example, the ornamental cornice of an 1866 limestone building was missing; and the ground level storefront had been extensively altered. (b) and (c) Based on the availability of photographic and other documentation, the owners were able to accurately restore the cornice and storefront to their historic configuration. A substitute material, fiberglass, was used to fabricate the missing pressed metal cornice, an acceptable alternative in this project. All work met the Standards.*

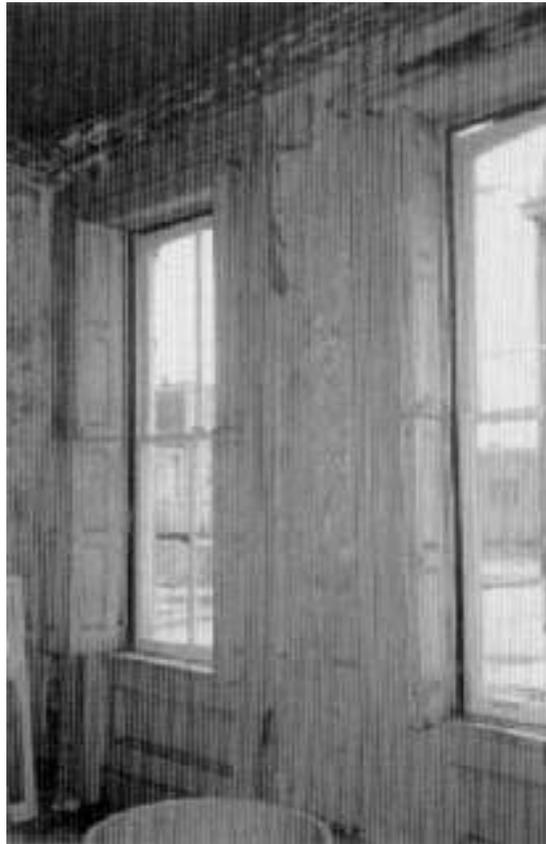
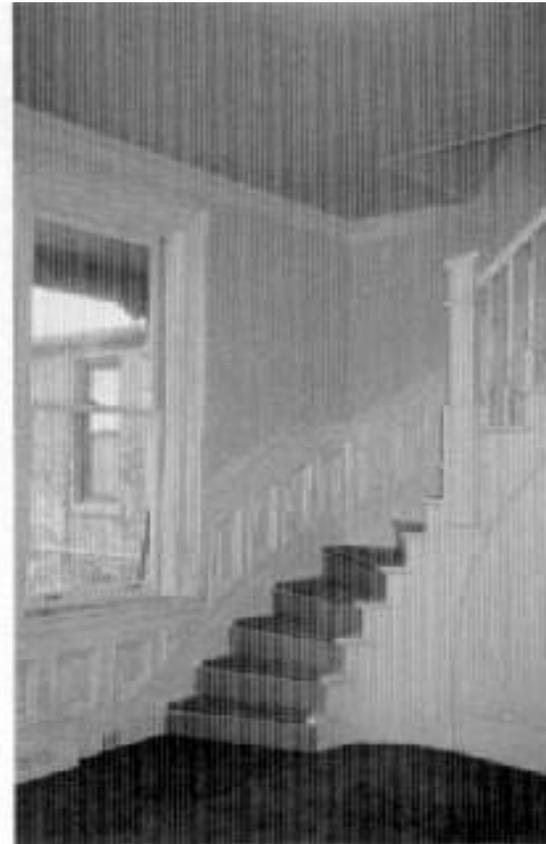
*Rehabilitating historic dwelling units often includes some level of lead-paint hazard abatement. Whenever lead-base paint begins to peel, chip, craze, or otherwise comes loose (a), it should be removed in a manner that protects the worker as well as the immediate environment. In this example (b), the deteriorating lead-paint was removed throughout the apartment building and a compatible primer and finish paint applied. Photos: Sharon C. Park, AIA.*

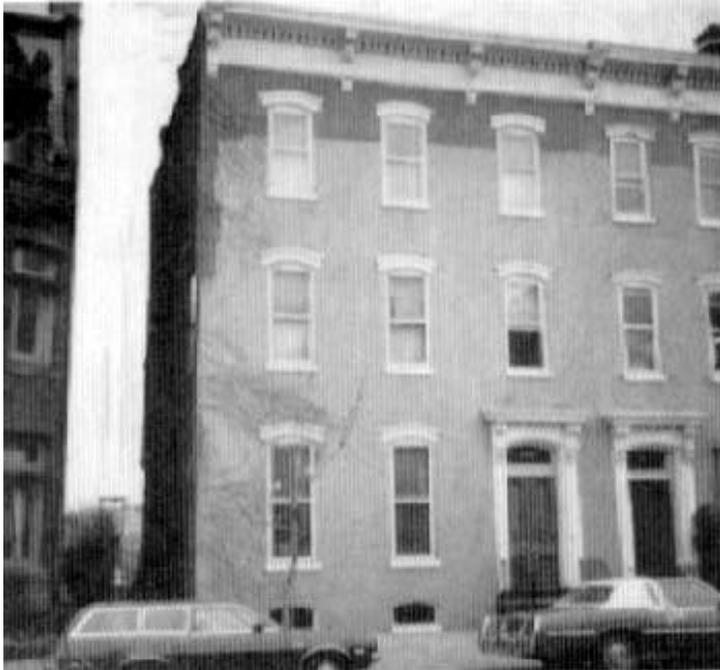
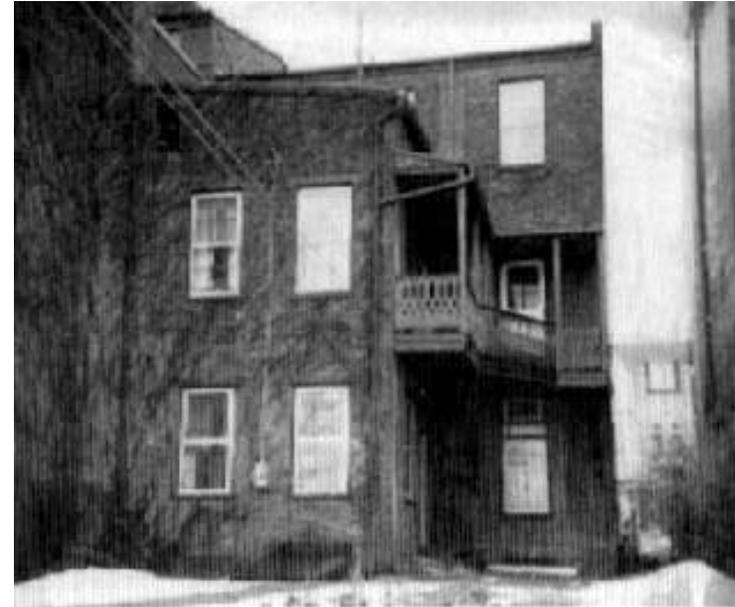
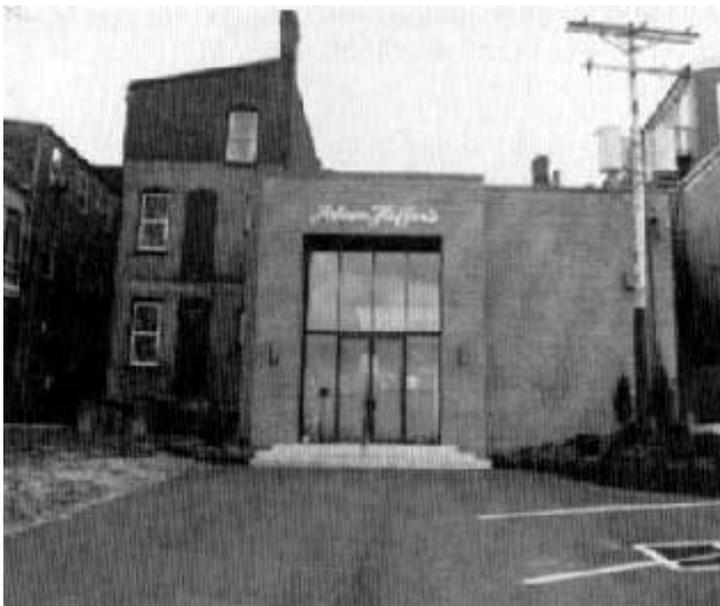
*If a rear elevation of a historic building is distinctive and highly visible in the neighborhood, altering it may not meet the Standards. (a and b) This 3-story brick rowhouse featured a second story gallery and brick kitchen wing characteristic of other residences in the district which backed onto a connecting roadway. (c) In the rehabilitation, the wing and gallery were demolished and a large addition constructed that severely impacted the building's historic form and character*

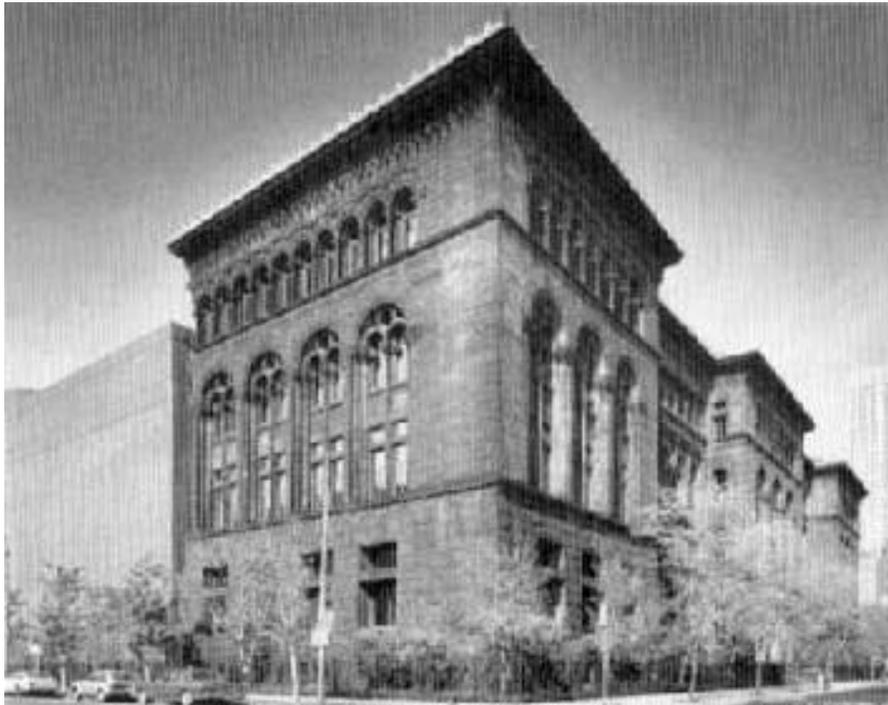
Constructing a new addition so that there is the least possible loss of historic materials and so that character-defining features are not obscured, damaged, or destroyed.

Designing a new addition in a manner that makes clear what is historic and what is new.
