Project No.
9450.000.000

March 29, 2012
Revised June 4, 2012

Subject: 31 South Milpitas Boulevard
APN 086-28-041
Milpitas, California

PHASE II ENVIRONMENTAL SITE ASSESSMENT

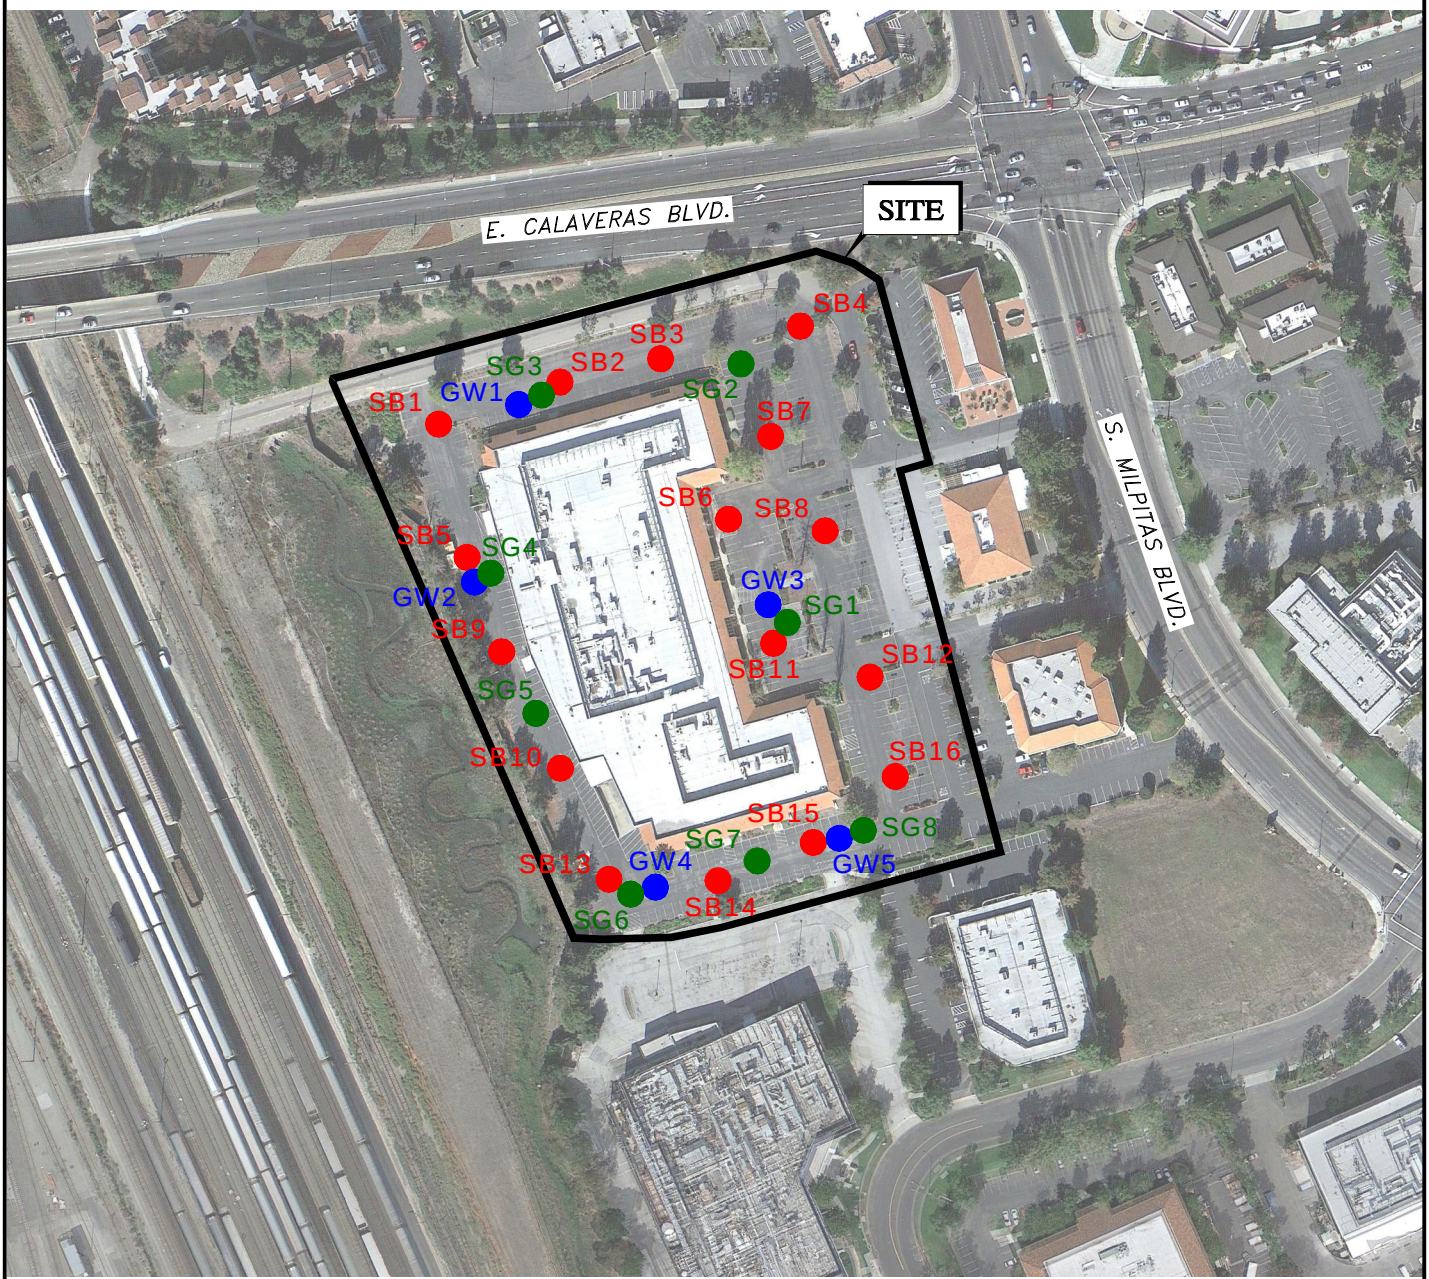
SITE PLAN

Subsurface soil and groundwater samples were collected from a variety of locations across the Property as shown in Figure 2. Soil samples were retrieved within continuous Geoprobe® acetate core liners measuring 4 feet in length. One-inch-diameter PVC casings with a 5- to 10-foot screen length were temporarily placed into each boring to facilitate groundwater sample collection. Grab groundwater samples were recovered using disposable bailers at each location and decanted into appropriate laboratory glassware. Borings were advanced to approximately 20-25 feet below the ground surface (bgs). Soils were continuously screened and checked for staining or olfactory constituents.
