Appendix E – Geotechnical Report

**PRELIMINARY GEOTECHNICAL
ENGINEERING INVESTIGATION
McCARTHY RANCH
MILPITAS, CALIFORNIA**

Re: Preliminary Geotechnical Engineering Investigation
McCarthy Ranch Shopping Center
Milpitas, California

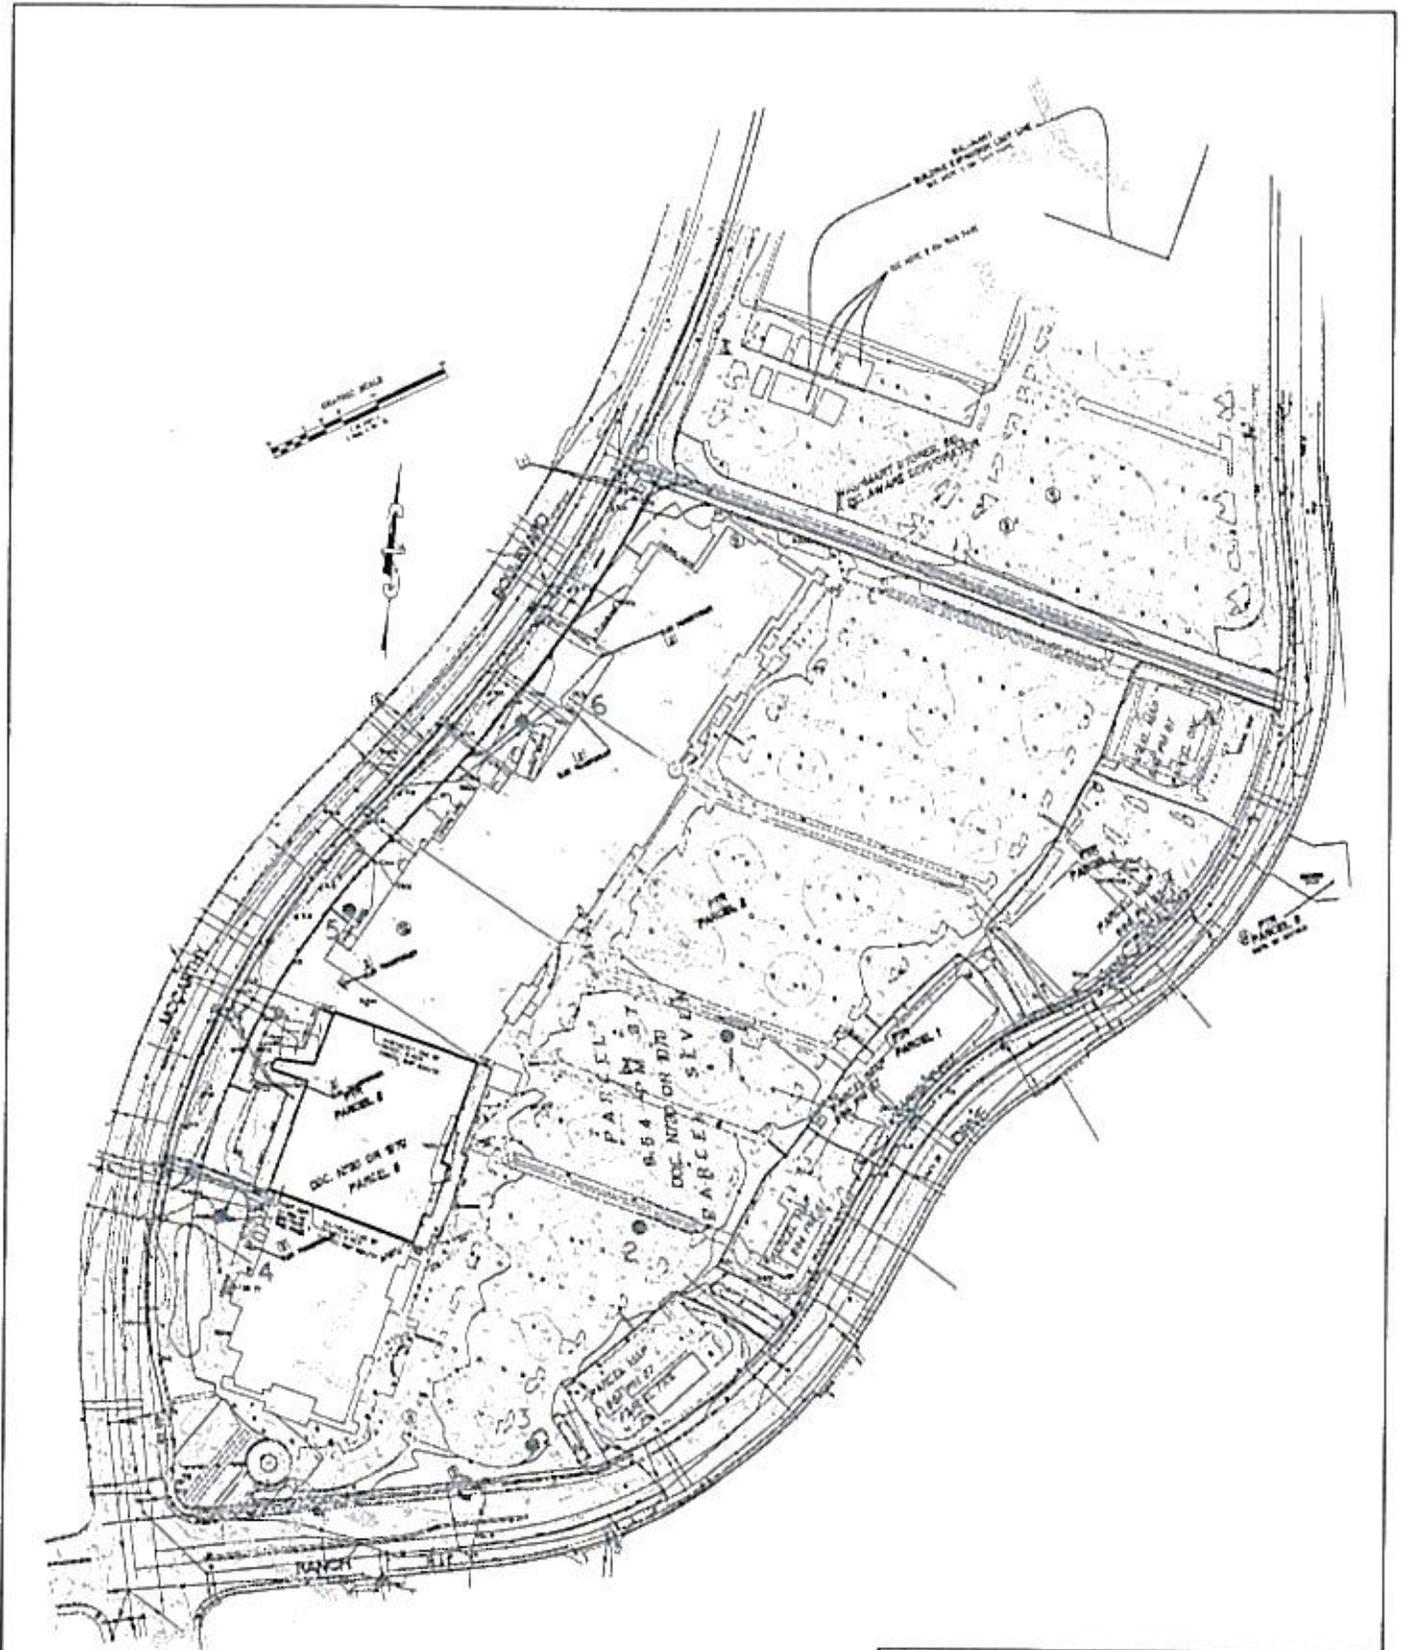
Figure
 1

● Approximate Location of Cone Penetration Tests (Typ.)

Jensen - Van Lienden
 Associates, Inc.
 CPT Location Plan
 McCarthy Ranch
 Milpitas, California

This report presents results of our investigation of soil conditions underlying the McCarthy Ranch shopping center on Ranch Drive in Milpitas, California. The site location is illustrated on Figure 1.

After examining the site, on November 22, 2011, we retained Lankelma Inc. to conduct six cone penetration tests (CPTs) at different locations throughout the site. The approximate positions of the CPTs are plotted on Figure 1.

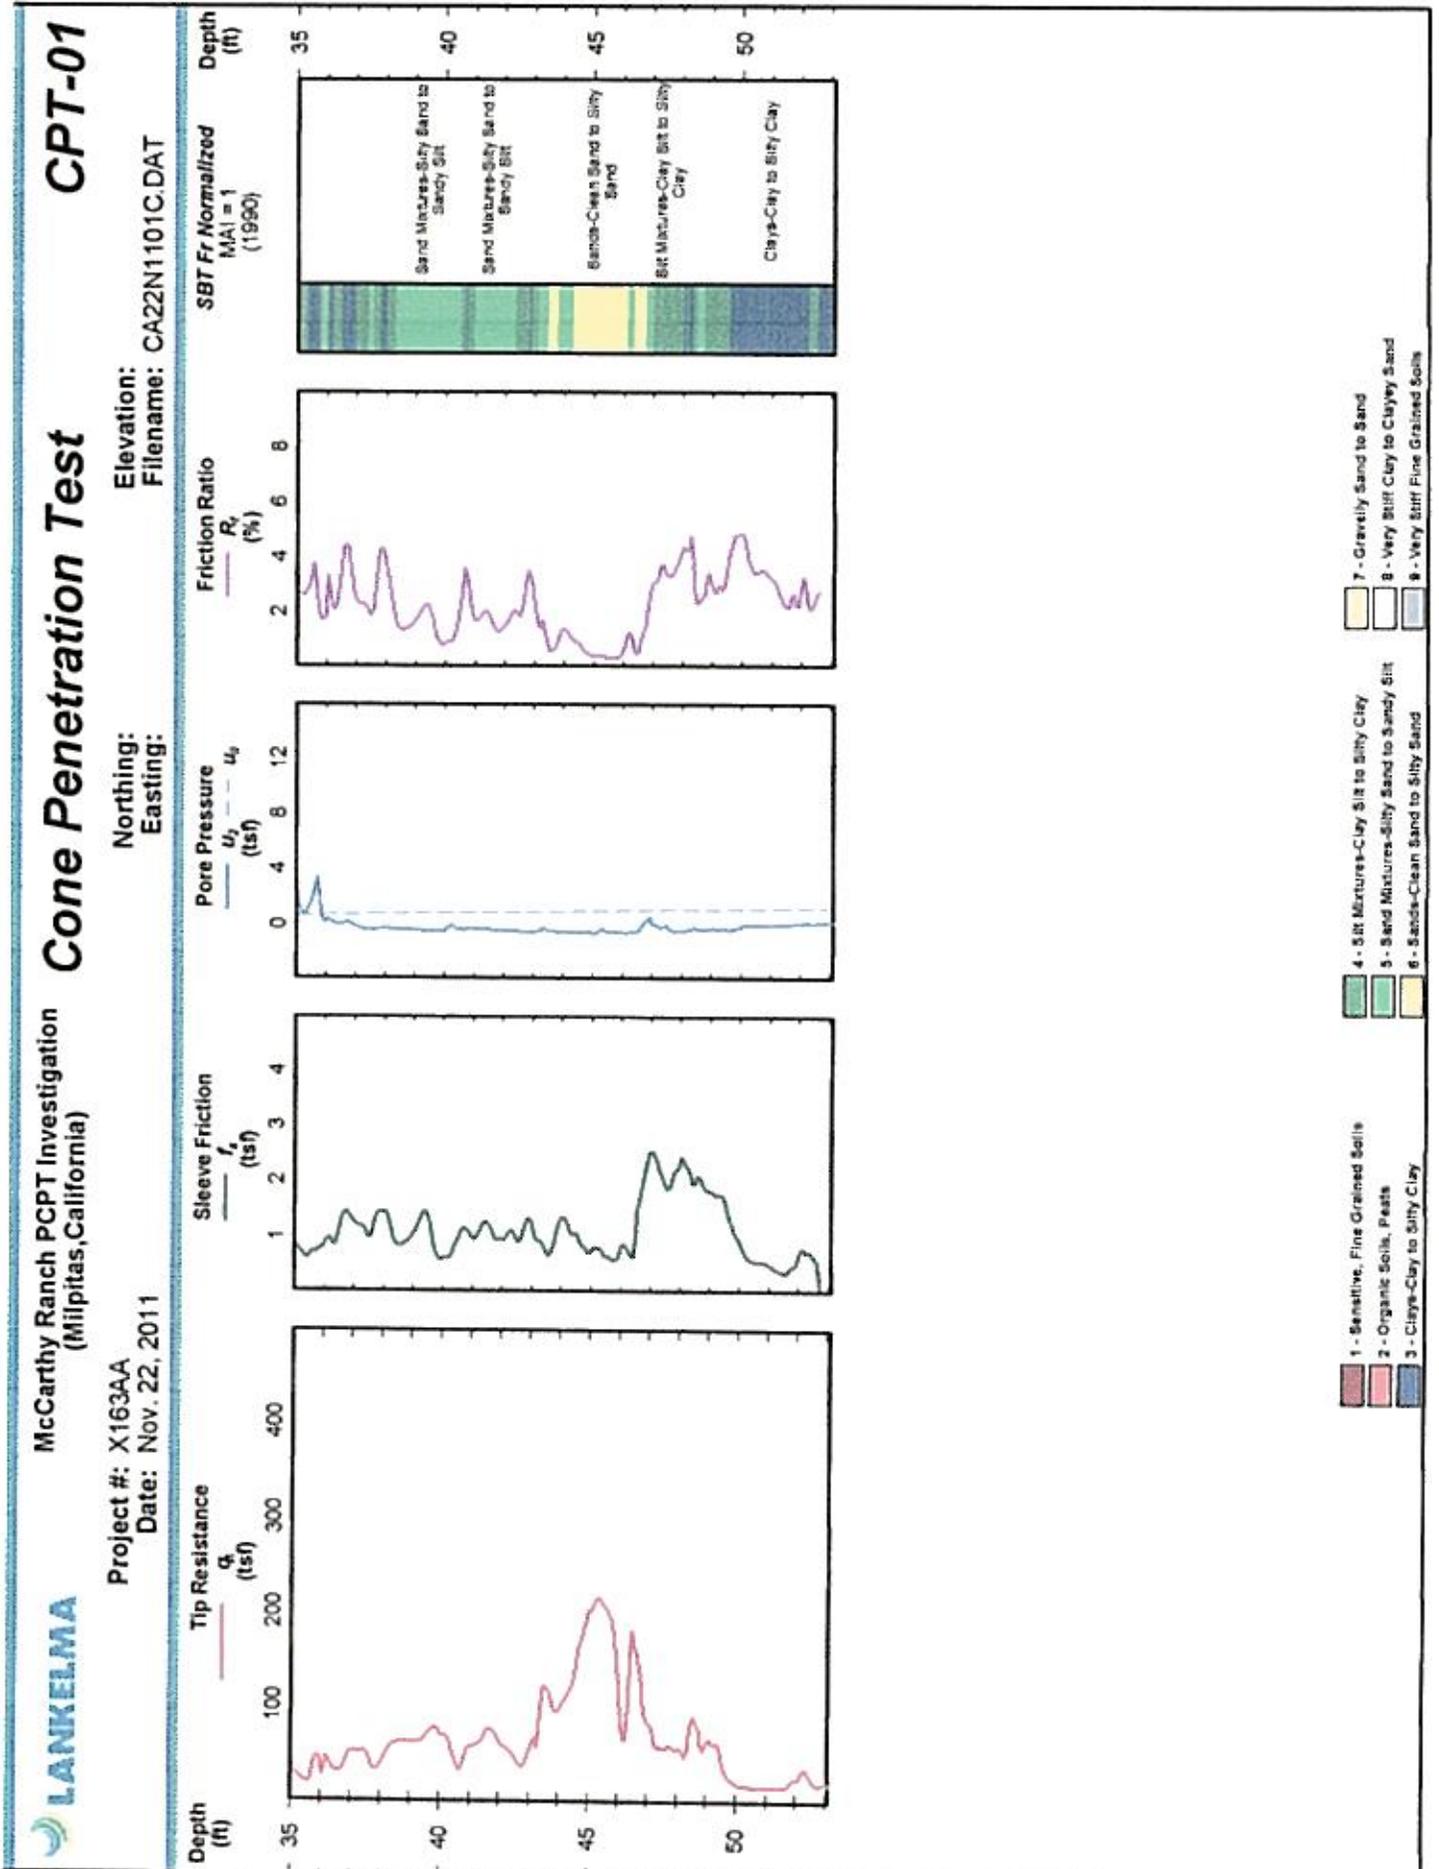
CPT-01

Cone Penetration Test

McCarthy Ranch PCPT Investigation
(Milpitas, California)

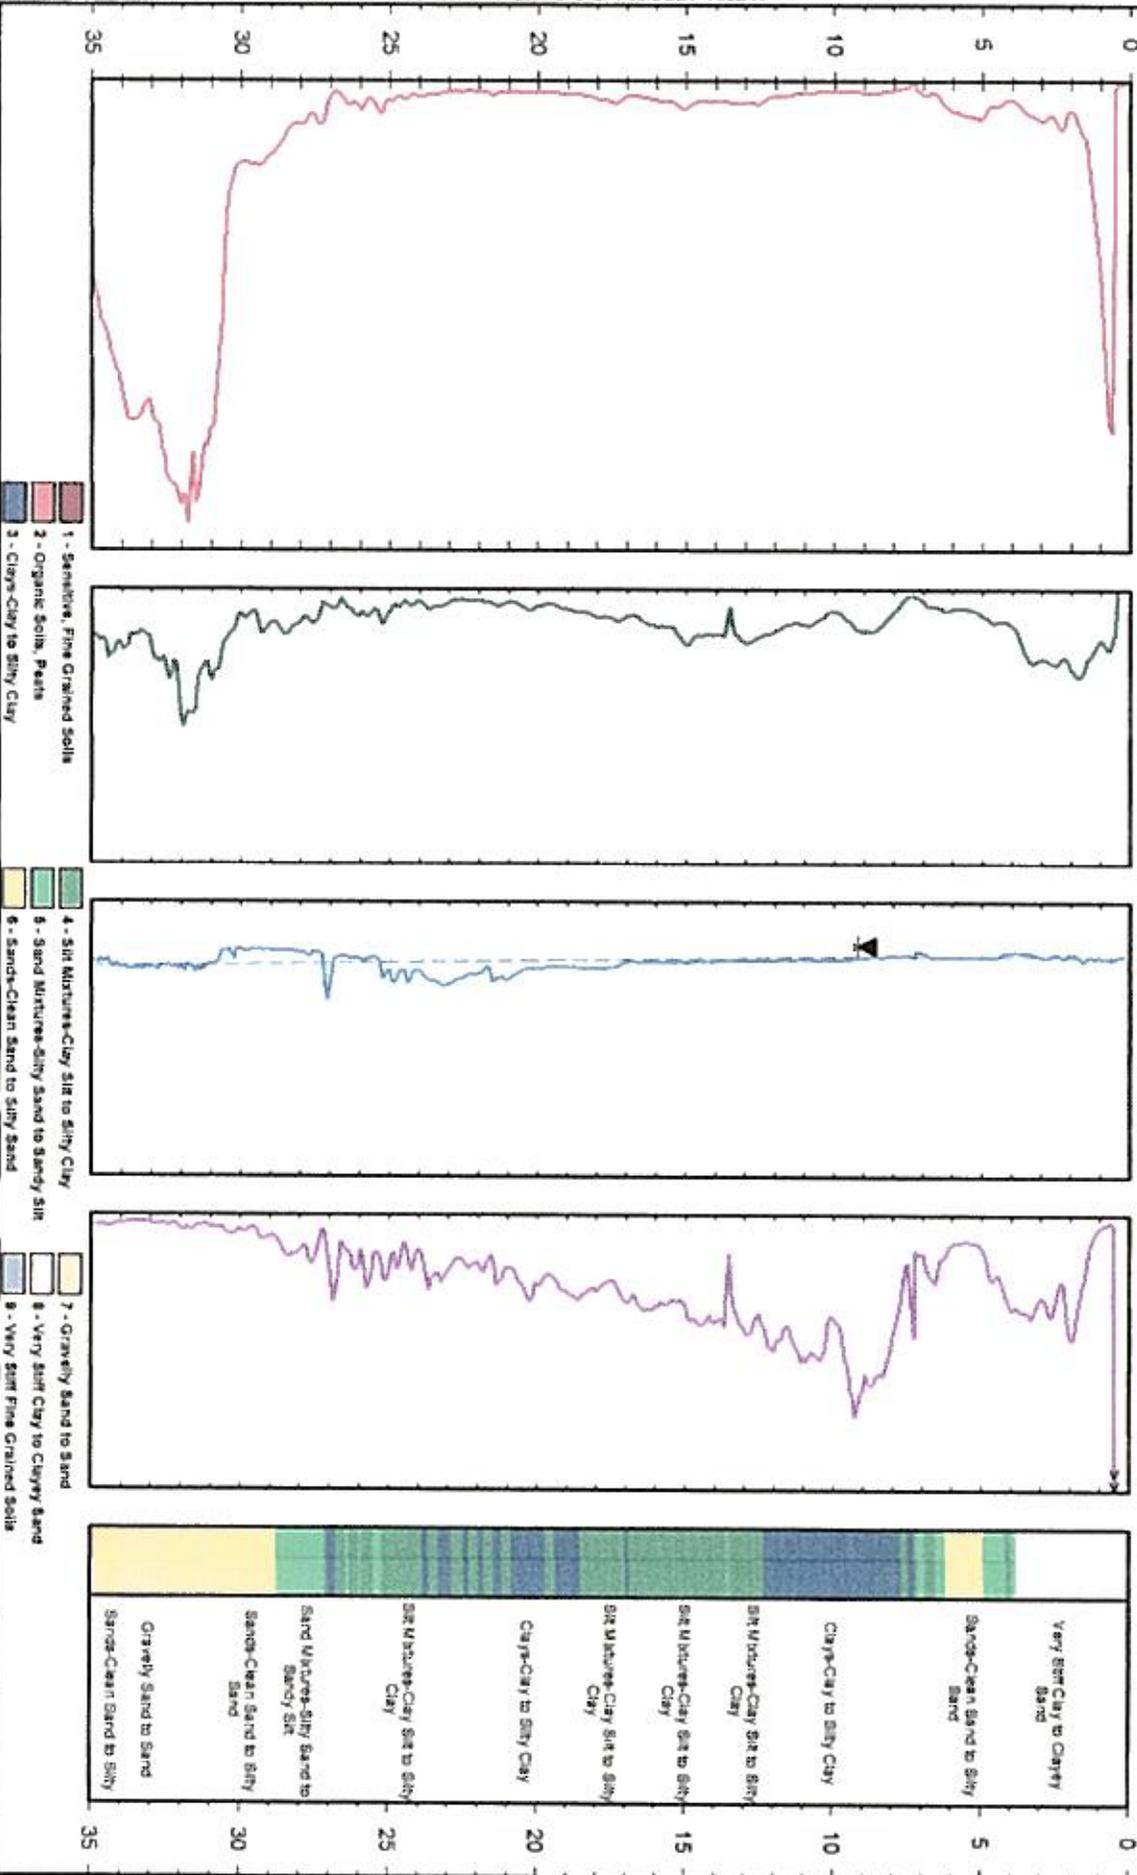
Figure 6

Depth (ft) Tip Resistance q_c (tsf) Sleeve Friction f_s (tsf) Pore Pressure u_z (tsf) Friction Ratio R_f (%) SBT Fr Normalized (1990) Depth (ft)

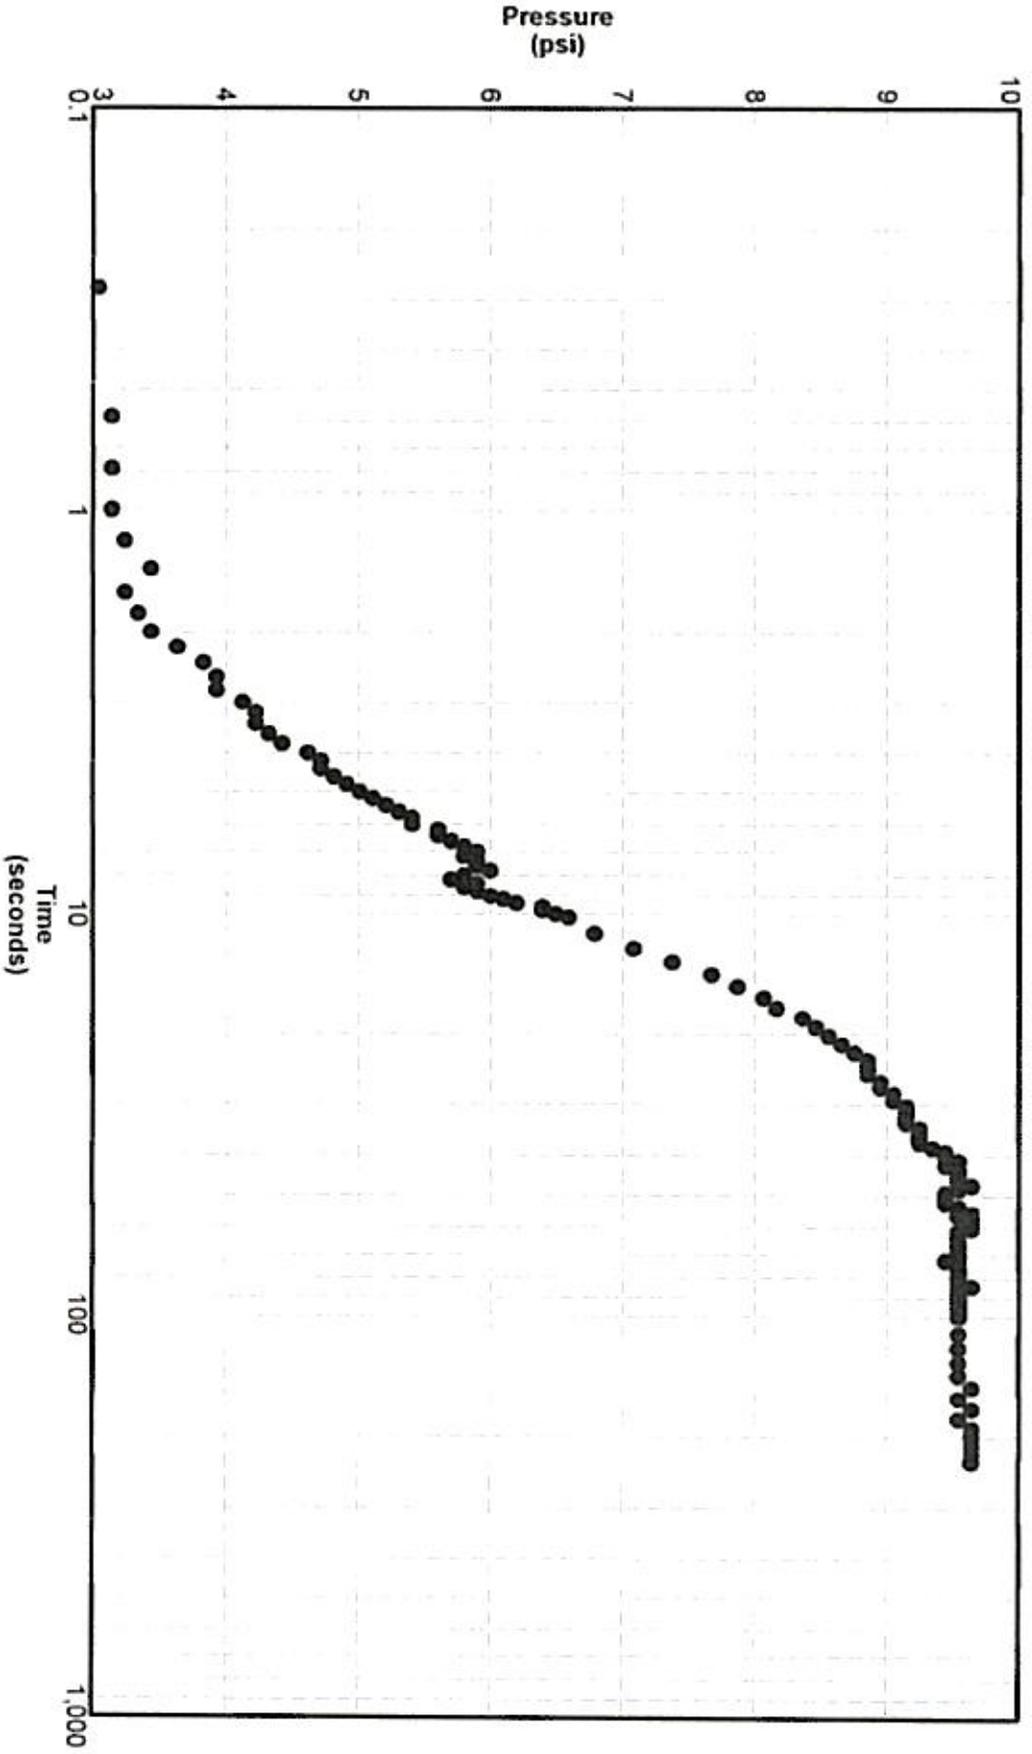
Figure 8

Pore Pressure Dissipation:

Total Depth: 53.1 ft
Termination Criteria: Target Depth
Test Depth: 36.2 ft

CPT-01

The cone instruments include a transducer that recorded the excess pore water pressure as the cone penetrated into the explored soils. We stopped the cone movement temporarily once at each test location in order to allow the excess pressure to dissipate, enabling a measurement of the static ground water head. The data from these dissipation tests are plotted on Figures 8 through 13.

As noted, the measured ground water surface depth ranged from 9.3 feet to 9.7 feet in CPTs 2 through 6 and at 14.1 feet in CPT 1. These depths correspond to approximate elevations between 0.1 feet (in CPT 1) and 6.7 feet (in CPT 5).

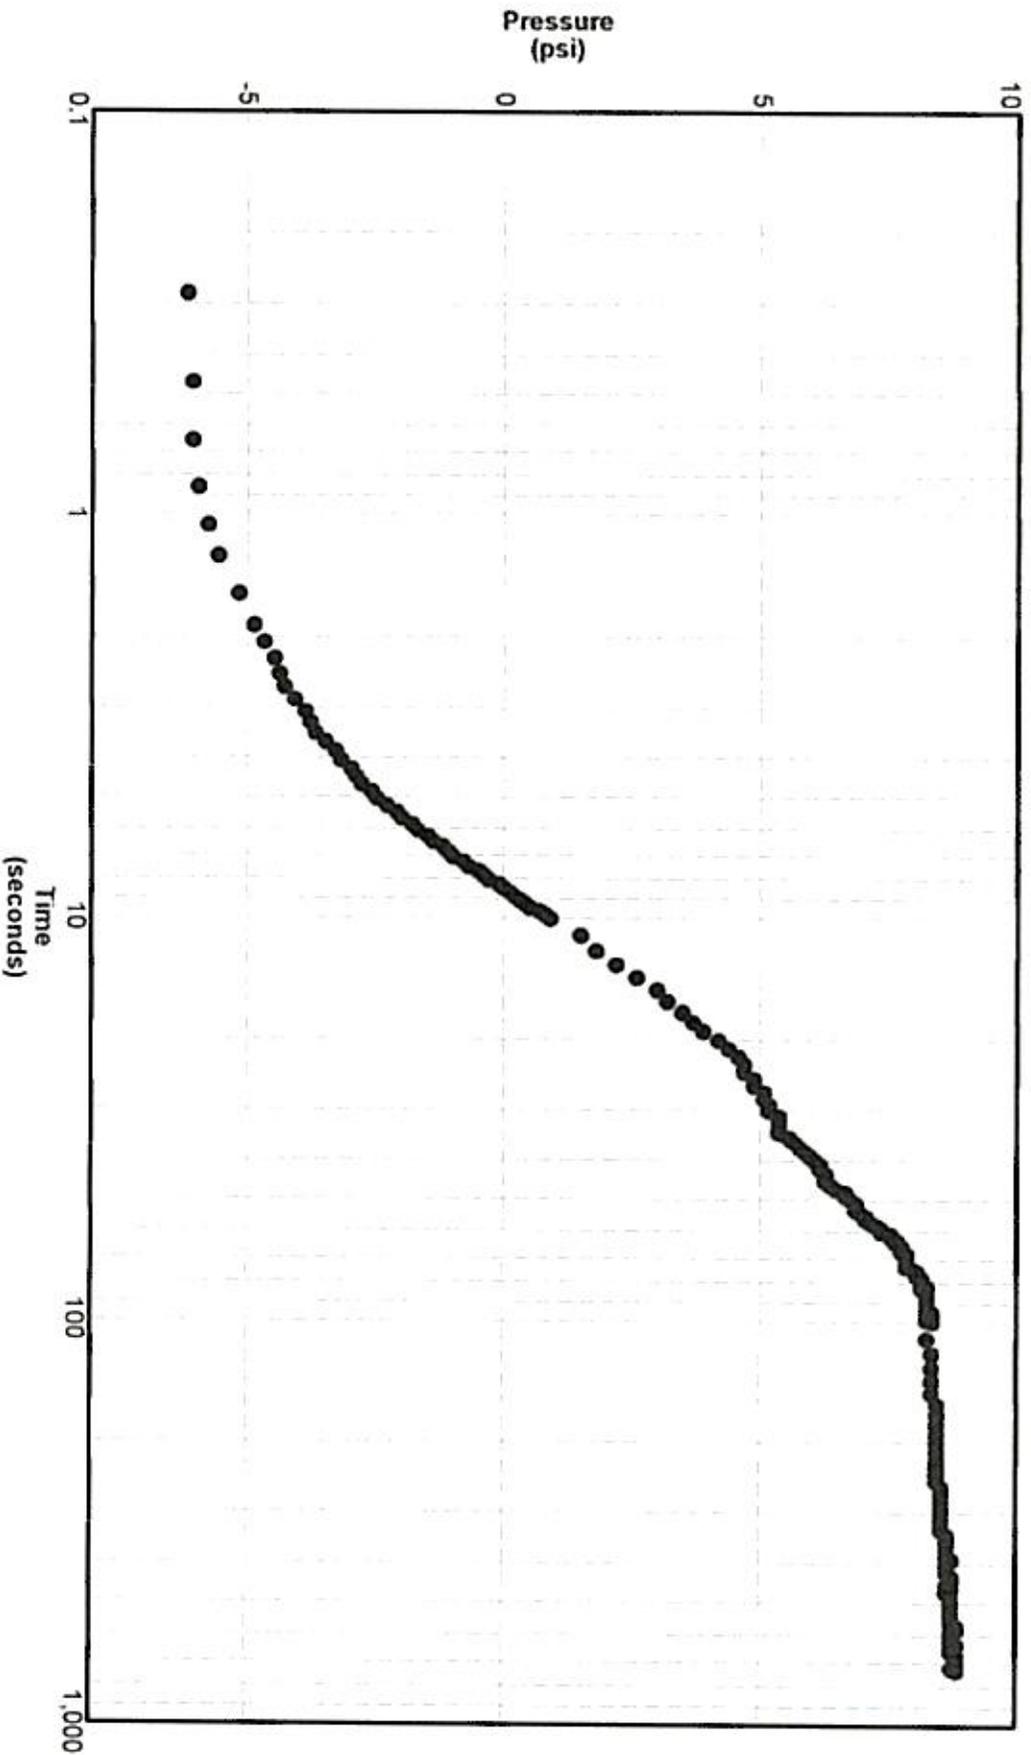
Pore Pressure Dissipation:

Date: Nov. 22, 2011
 Estimated Water Depth: 9.3
 Rig/Operator: JT | VB

Total Depth: 65.8 ft
 Termination Criteria: Target Depth
 Test Depth: 48.8 ft
